**ATMOSPHERIC STORAGE TANK  
API 653 EXTERNAL & ULTRASONIC  
IN-SERVICE INSPECTION REPORT**

SHELL PIPELINE COMPANY, LP

TANK NO. 6

ST. JAMES TERMINAL

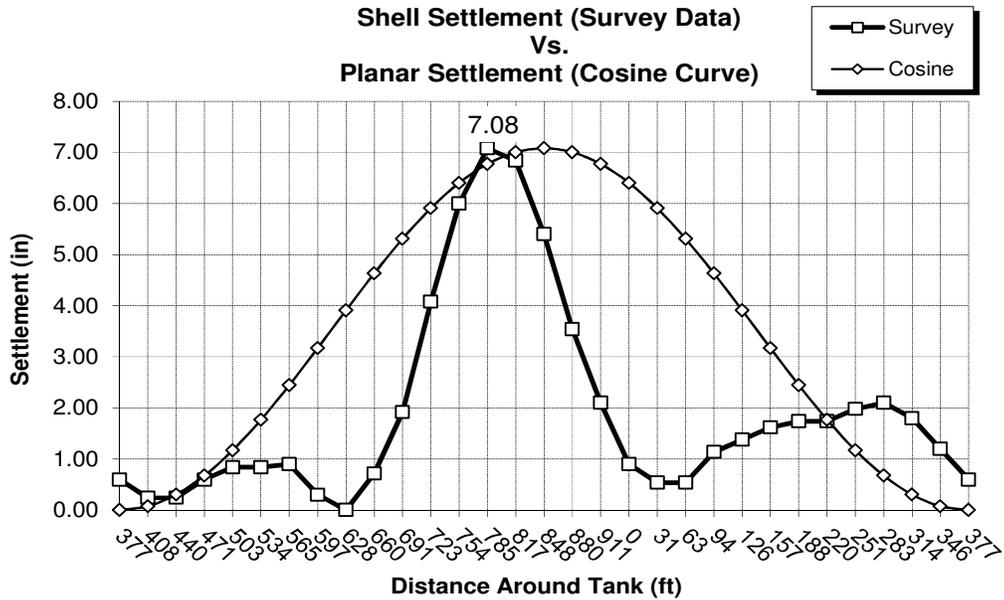
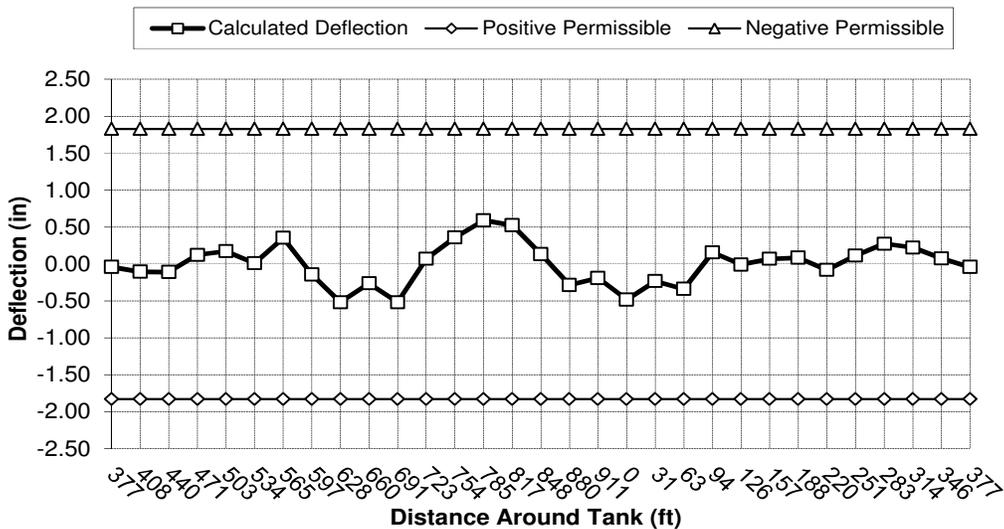
##### 3.1.1 FOUNDATION SETTLEMENT EVALUATION

**ITEM F2:** The survey found the tank out of level by 7.08 inches. API 653 calculation for deflection of this tank is 0.59 inch. API maximum deflection permitted for this tank is calculated at 1.83 inches (ref. API 653, Appendix B, Para. B.3). Differential settlement for this tank does not exceed the API allowable (ref. API 653, Appendix B, Para. B.3). Future settlement should be monitored during the next API 653 external inspection.

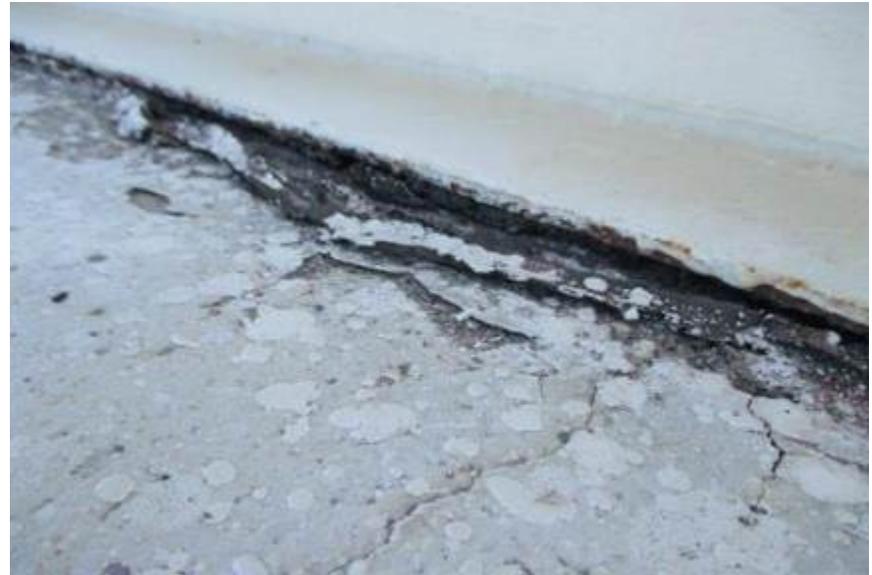
**ITEMS F11:** The visible portion of the moisture barrier has deteriorated. The seal material underneath the bottom edge projection is still in serviceable condition. Consideration should be given to replacing the moisture barrier at the next out-of-service inspection.

External Section of Moisture Barrier

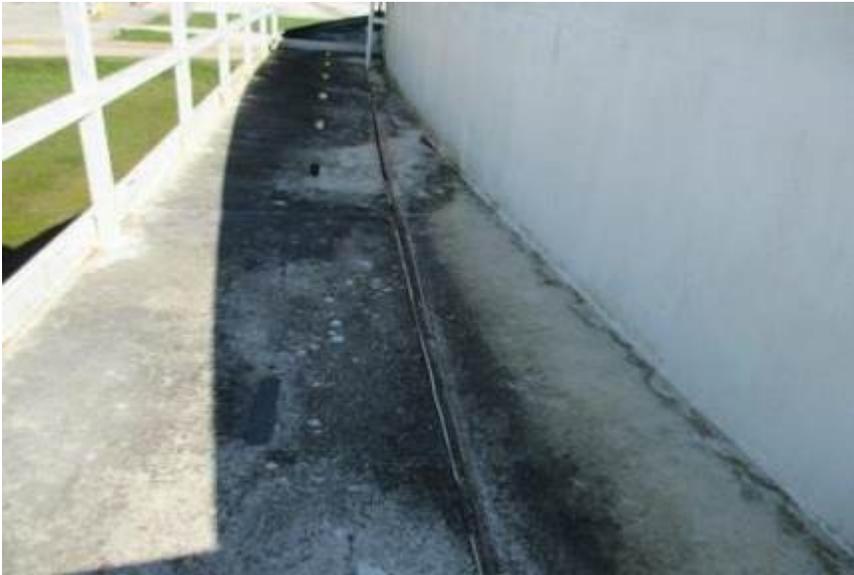
**ITEM S11:** There are two (2) wind girders installed on this tank at the top of Course 3 and on the upper section of Course 4. Visual (VT) inspection found both wind girders covered with surface mold and mildew. Consideration should be given to cleaning these items.

Mildew on Wind Girder

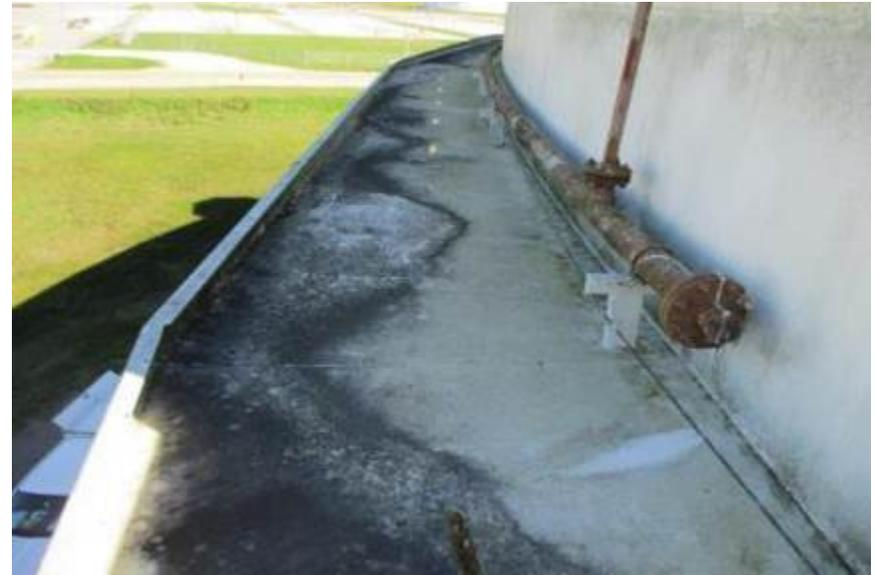
Mildew on Wind Girder

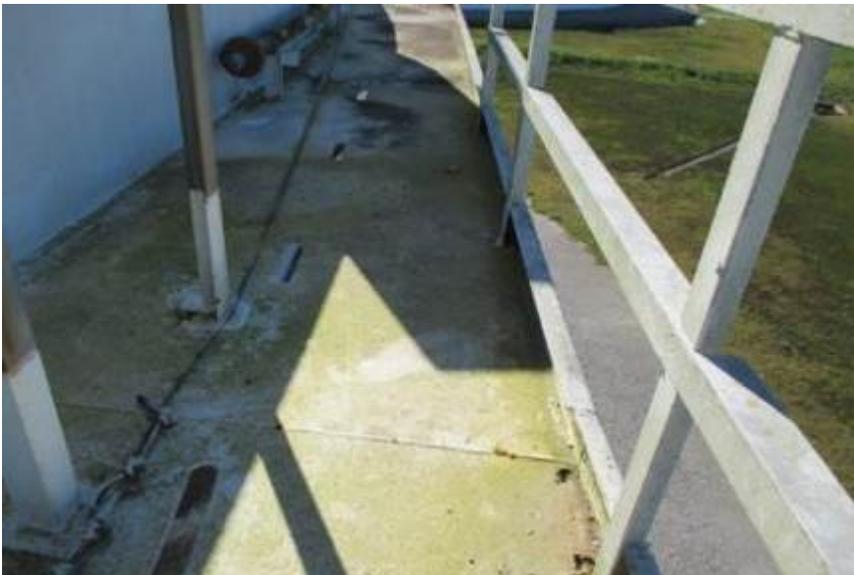
Mildew Present on Wind Girder

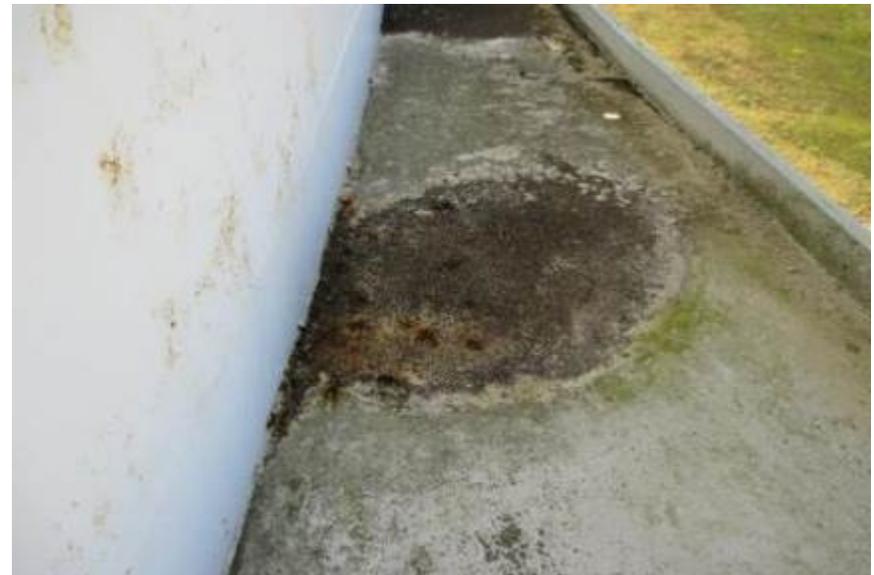
Standing Water and Mold on Wind Girder

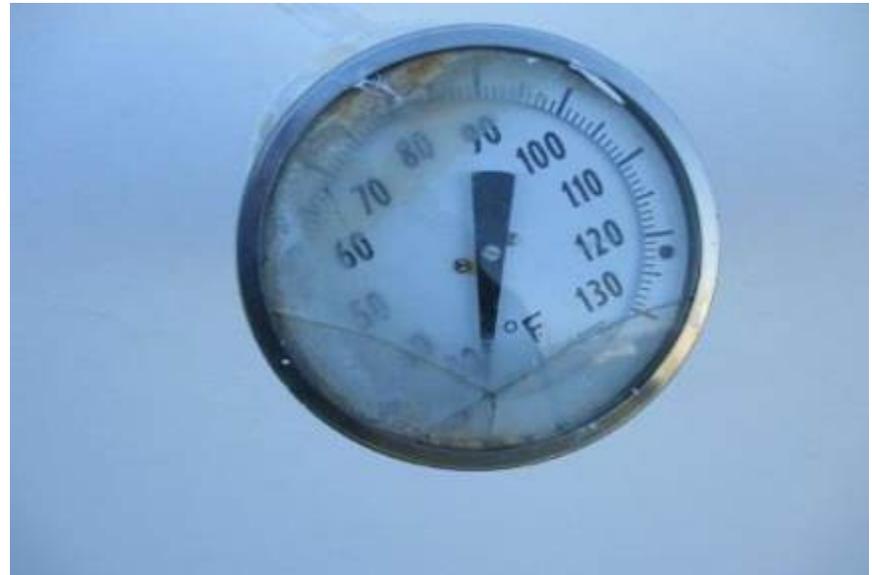
**ITEM N8:** Inspection of the temperature indicator noticed that the sight glass is broken. The indicator is not in use. Consideration should be given to replacing this detail.

Temperature Gauge Broken

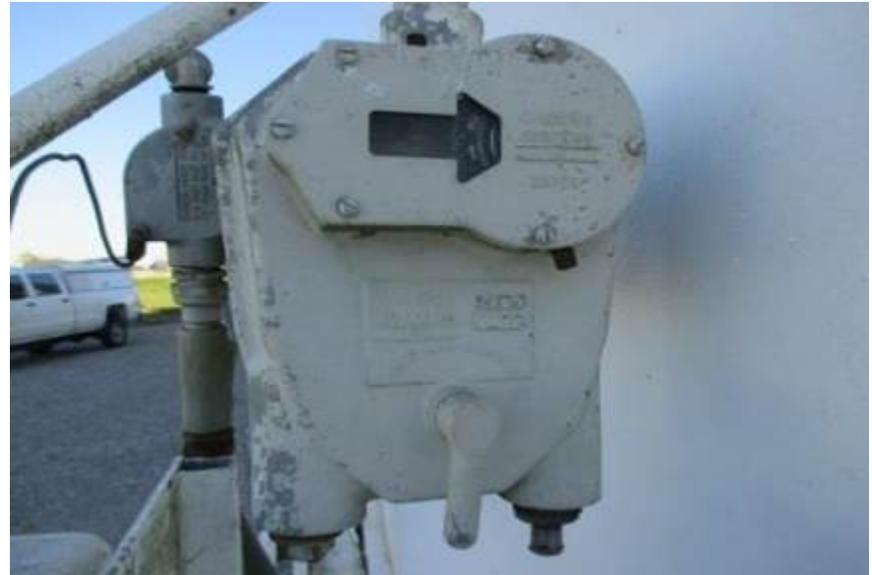
Automatic Gauge D

**ITEM N9:** The automatic gauge level is not showing the actual level product due to missing parts. Consideration should be given to repairing and calibrating this device.

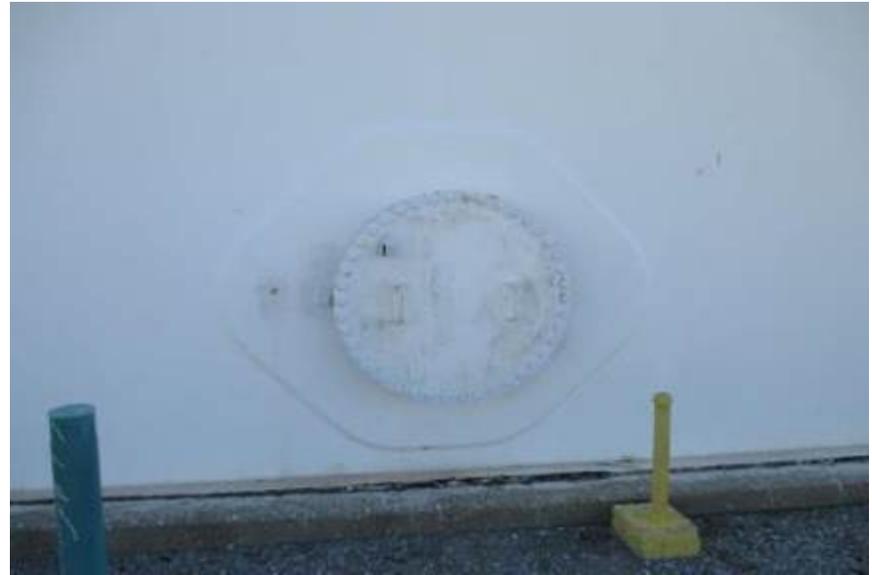
Manway I

**ITEM N2:** Manways I, Q, and Y have weld spacing between their reinforcing plate welds and the shell-to-bottom weld that is less than that required by API 650, Para. 5.7.3. Such practice results in areas of increased stress concentration and possible accelerated corrosion. Visual (VT) inspection of these manways / nozzle details did not identify any such corrosion at this time. Consideration should be given to modifying these penetration details in accordance with API 650 guidelines the next time this tank has major repairs to the shell or when hydrostatic testing is required for other reasons. These areas should be monitored in future for signs of accelerated corrosion due to possible increased stress concentrations.

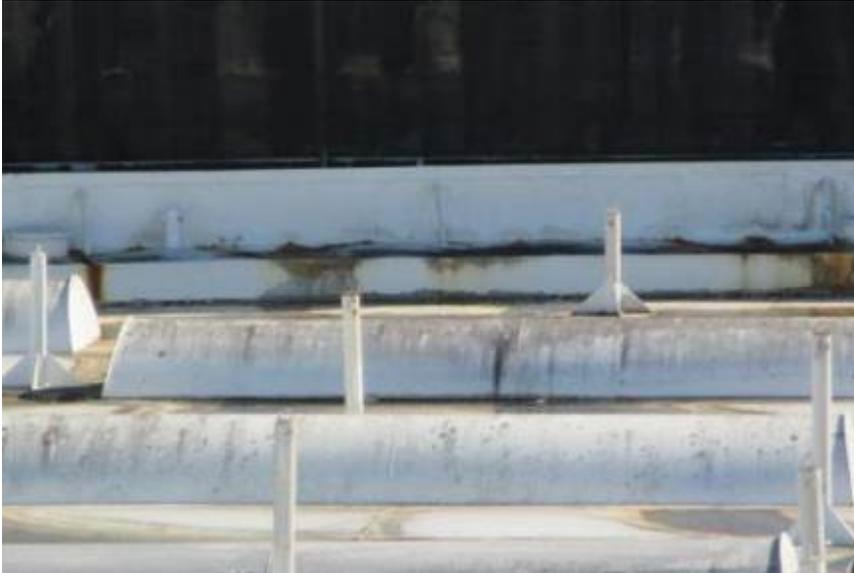
**ITEM FLR28:** The tank was in service. Visual (VT) inspection of the external floating roof was performed from the platform only due to safety concerns. The floating roof coating is in poor condition. No evidence of product or any other evident defects were noted on the floating roof deck.

Coating Failure

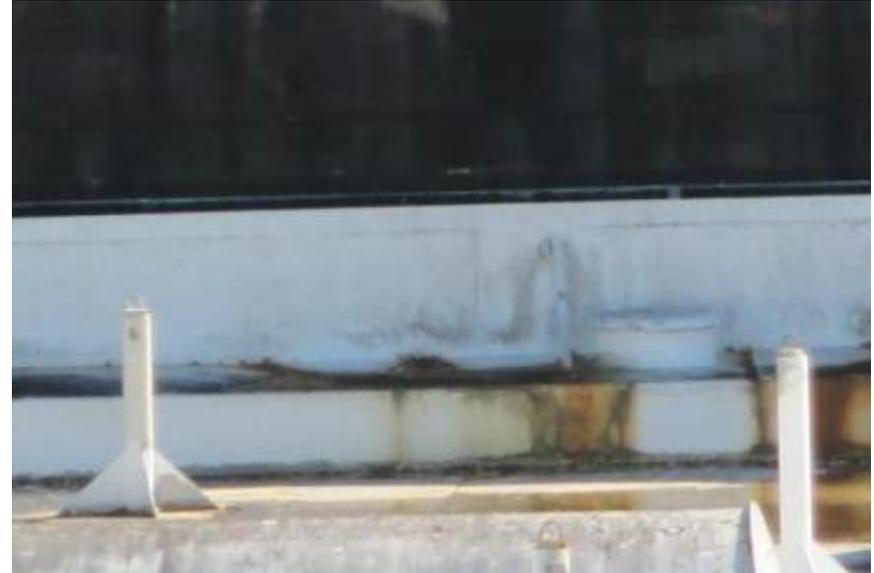
Coating Failure and Rust

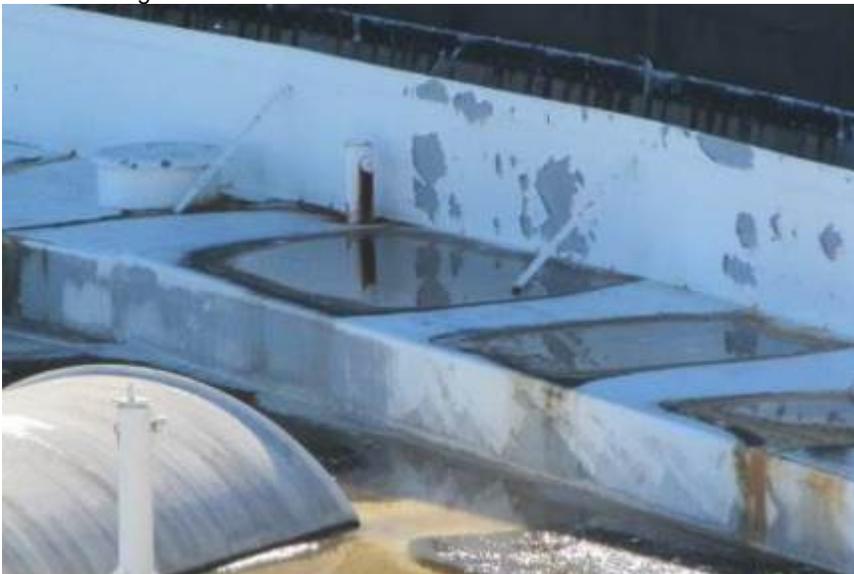
**ITEM FLR37:** Visual (VT) inspection of the floating roof revealed low areas that are retaining water and debris. This condition was observed on the roof deck plates and pontoon deck plates. Due to the tank diameter and the presence of deck pontoons, Visual (VT) inspection was very limited.

Standing Water on Pontoon Deck

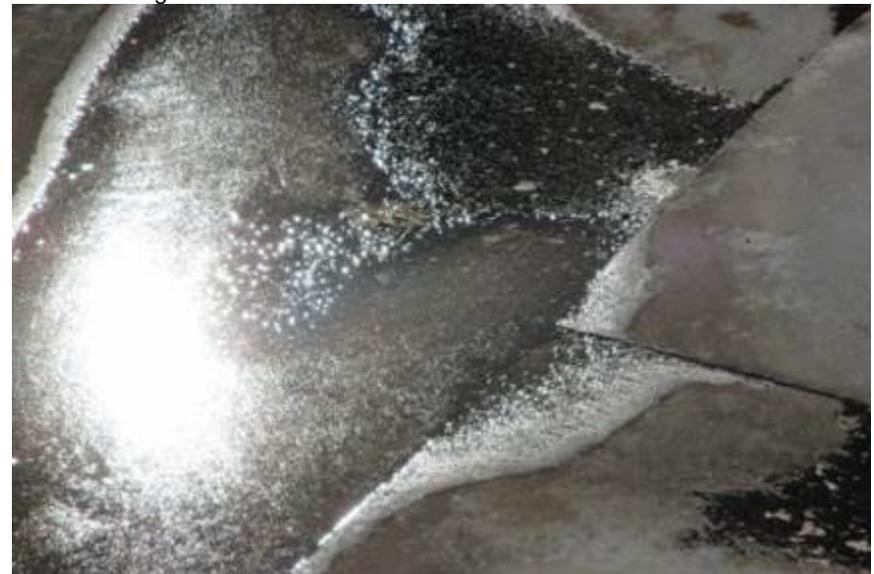
Standing Water on Roof Deck
