U.S. DEPARTMENT OF ENERGY
Strategic Petroleum Reserve
Project Management Office
New Orleans, Louisiana

**SHELL PIPELINE COMPANY LP
FY 2018 ANNUAL LEASE
PERFORMANCE EVALUATION OF THE
ST. JAMES (SUGARLAND) TERMINAL
(DE-RL96-97PO70010)**

October 24 & 25, 2018

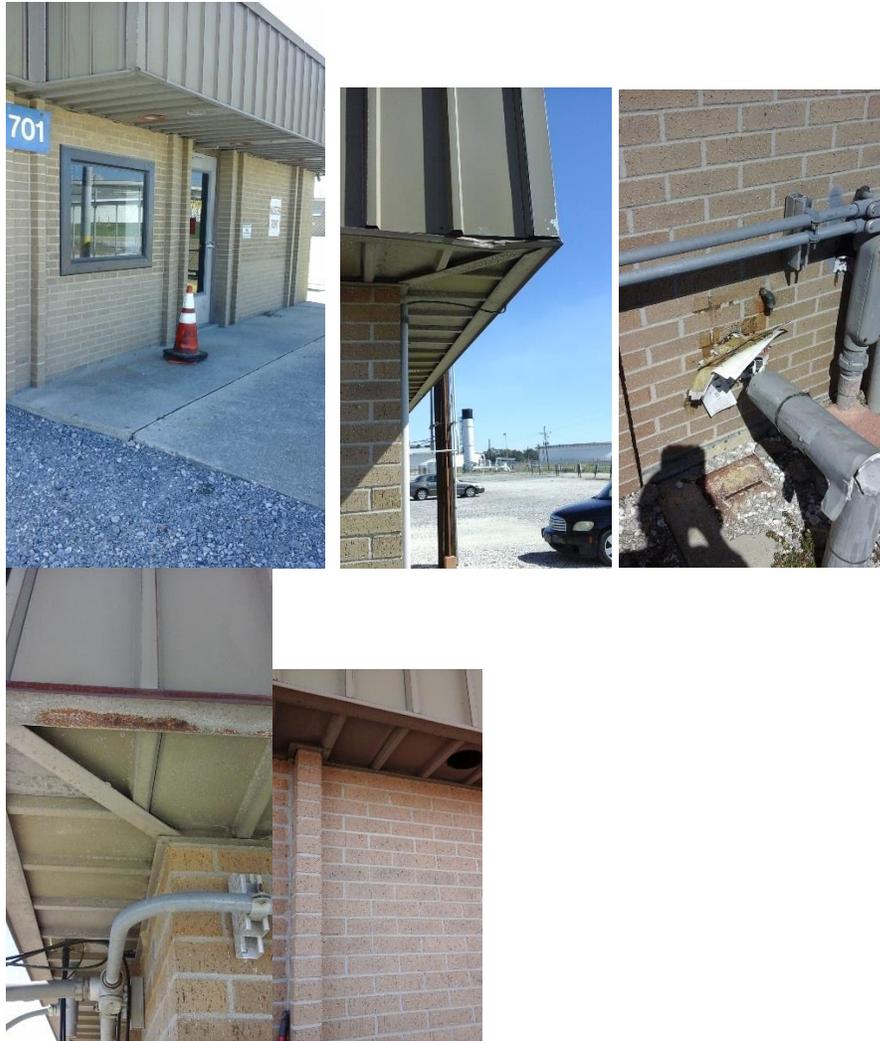
- i. Damage to aluminum siding.**
- ii. Utility room insulation damaged.**
- iii. Eave vent missing.**

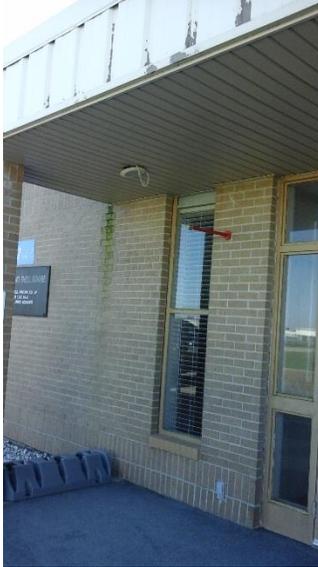
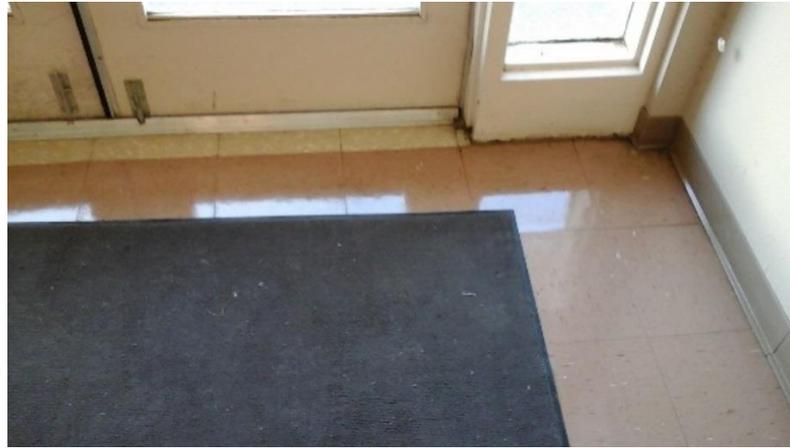
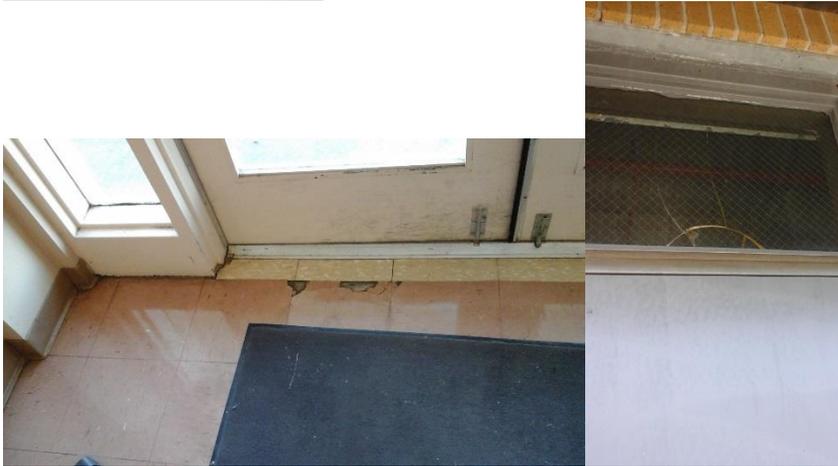
1. Building 702 (Administration)

- i. Damaged tile at front entry**

- i. Window over HVAC exterior door cracked.**
- ii. Building number extremely faded.**
- iii. Rust and oxidized paint on front entry door, frame, and adjoined windows.**

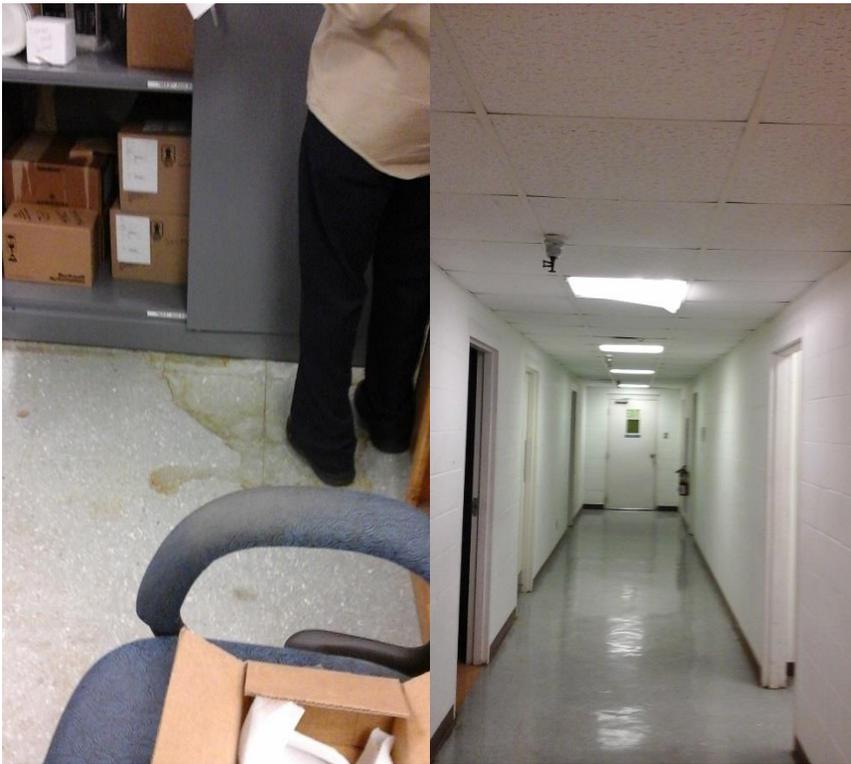
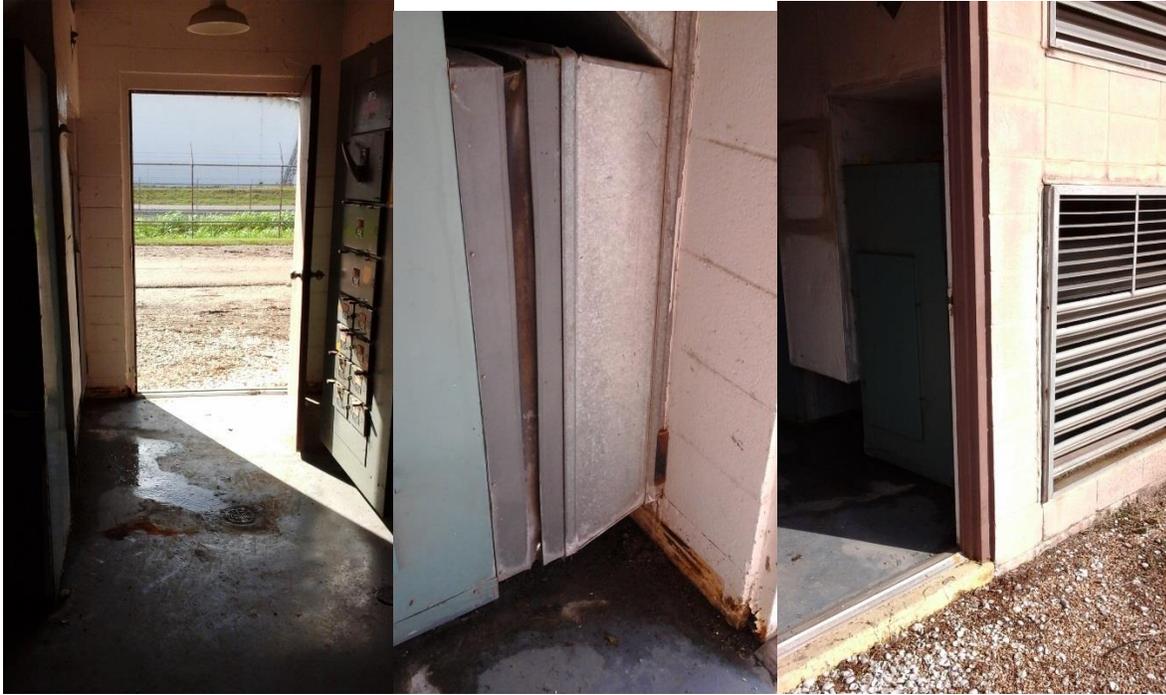
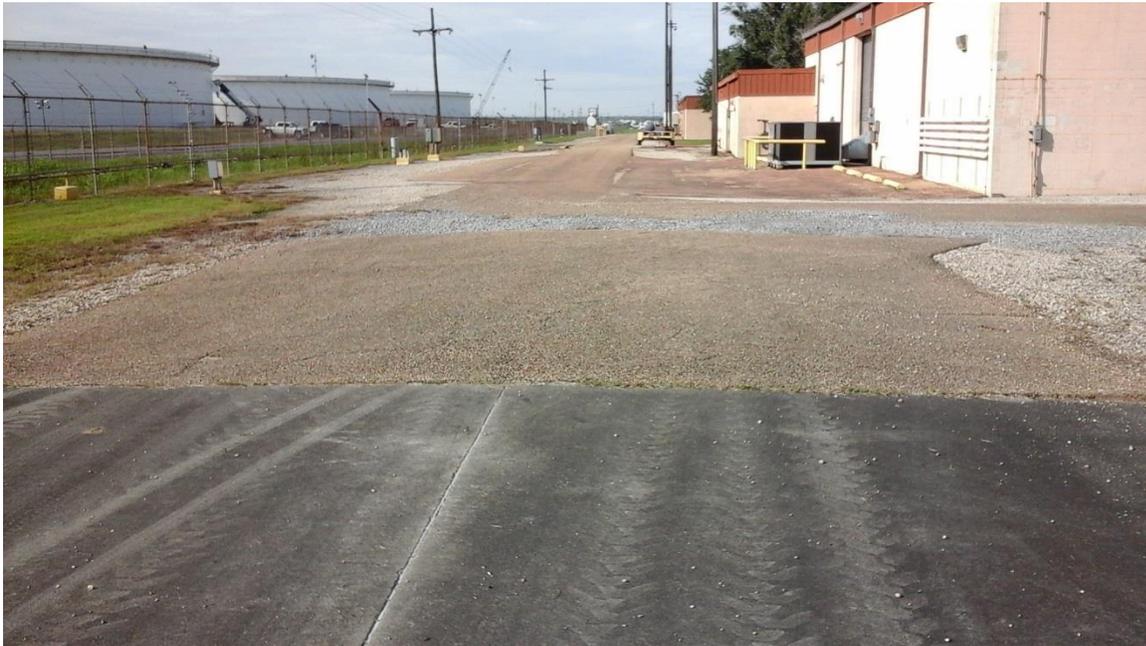
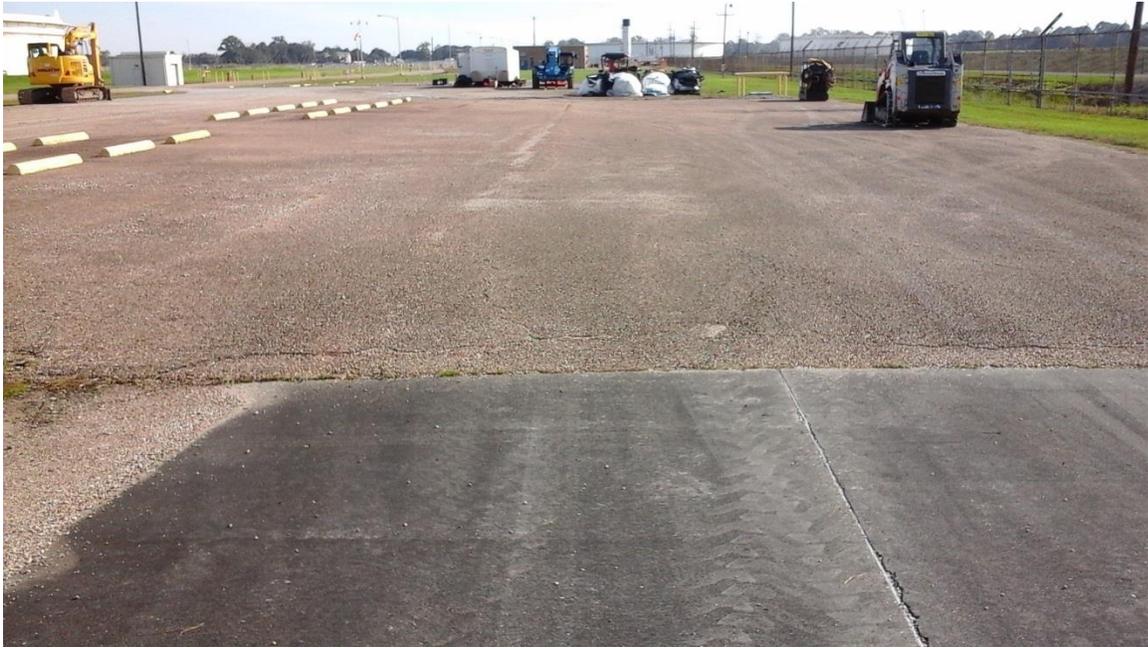
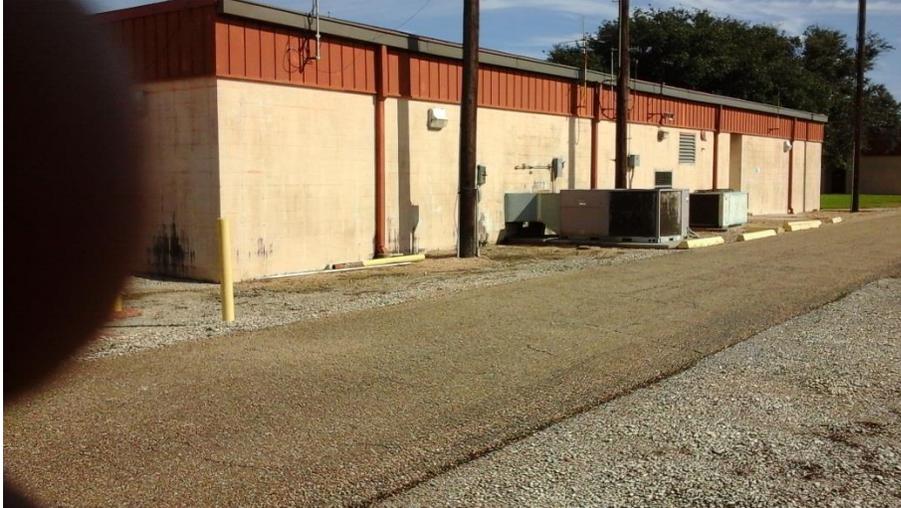
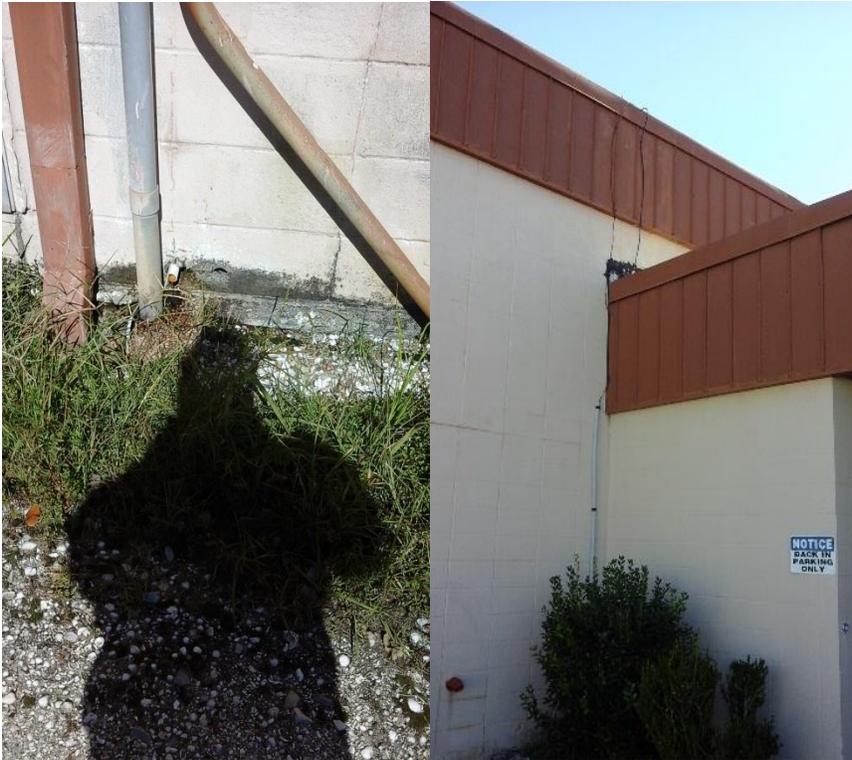
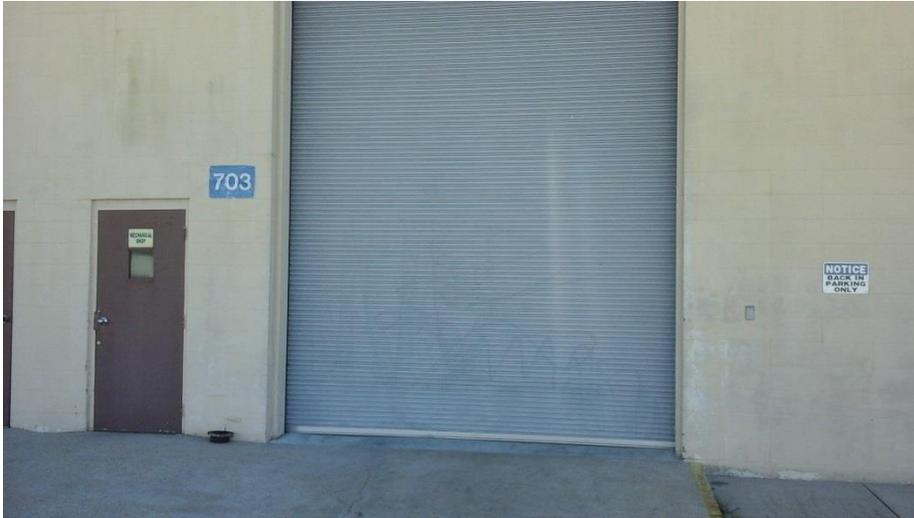
2. Building 703 (Maintenance)

- i. Spare office has water stains on floor.**
- ii. Light fixture has unsecured cover in hallway.**
- iii. Water intrusion through louver of HVAC system.**
- iv. Rust damage and cracked paint within HVAC utility area.**

- i. Exterior walls and eaves have oxidized and peeling paint.**
- ii. Soil / gravel subsidence at rear of building.**
- iii. Rear vehicle parking area eroding.**
- iv. Oxidized paint on roll up doors.**
- v. Building parking lot and parking striping indicators eroding.**

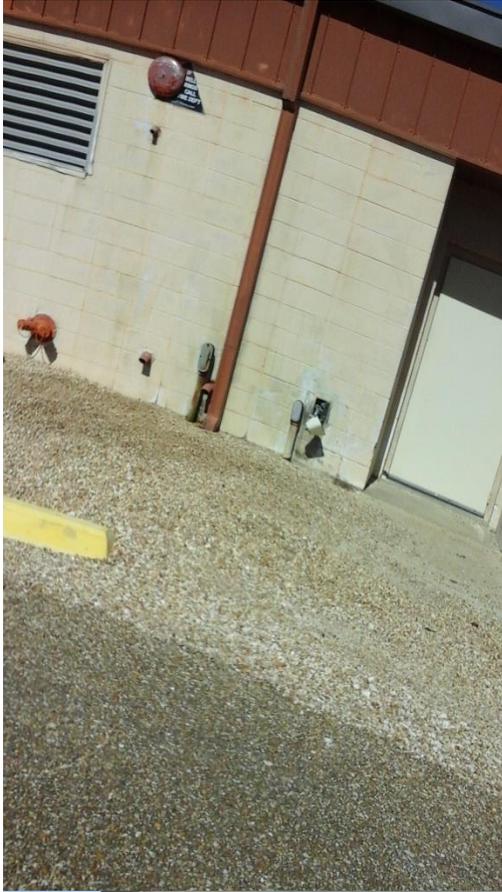
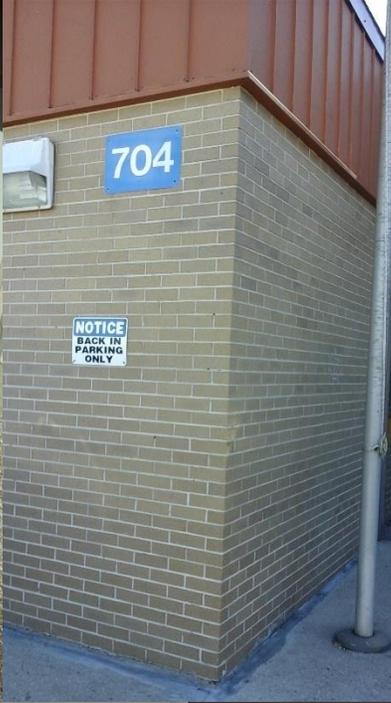
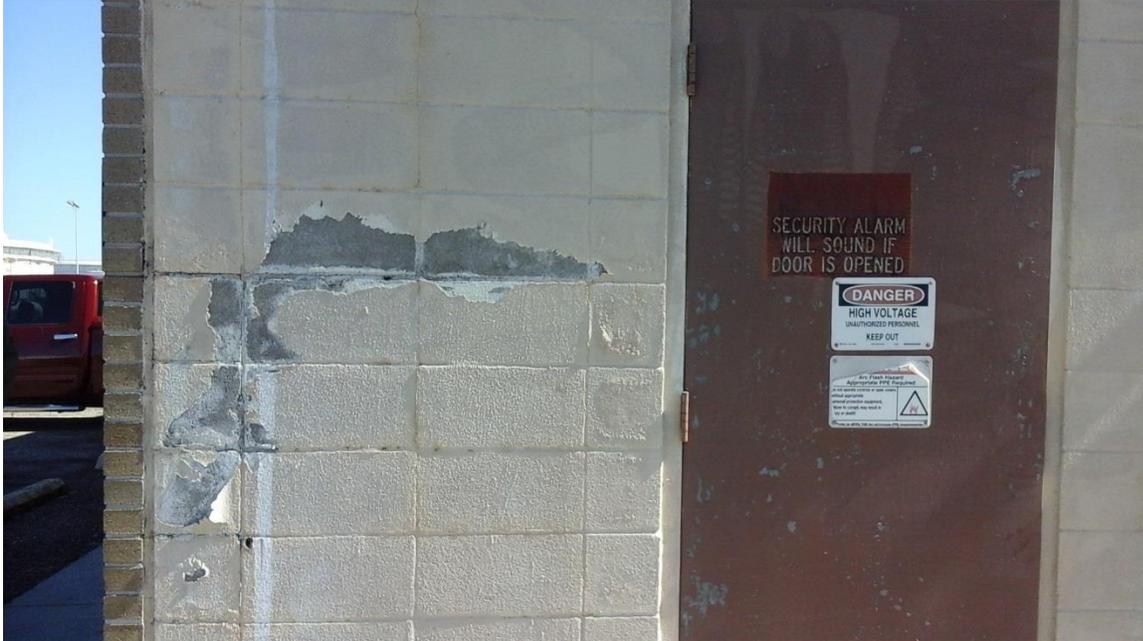
3. Building 704 (Control Room)

- i. Exterior walls and eaves have paint oxidized surfaces.**
- ii. Water barrier at foundation around the building cracking.**
- iii. Gravel/stone filled areas at the rear of building are eroding.**

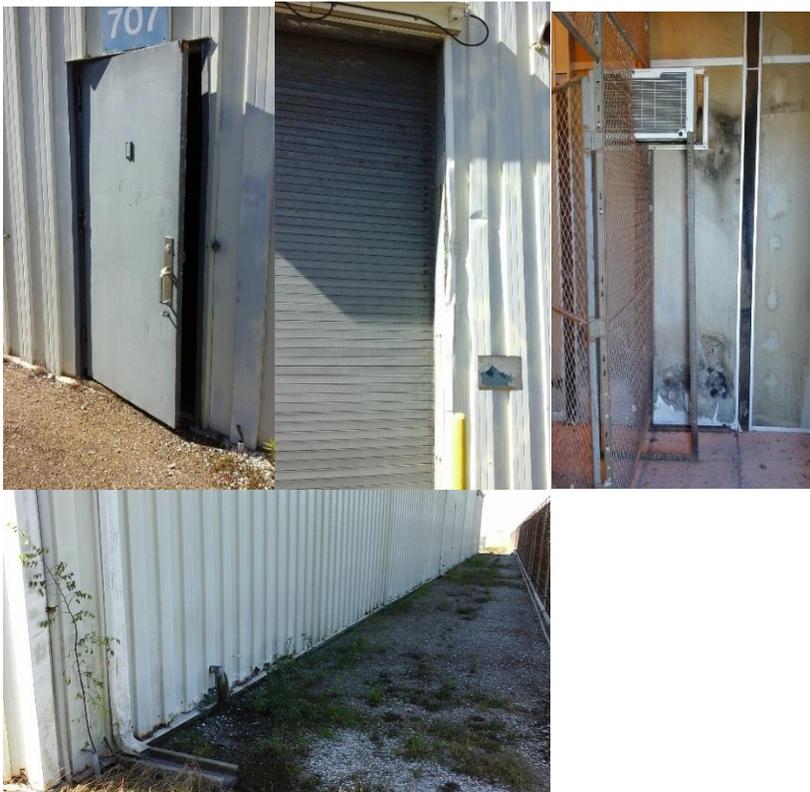
- i. Rust at foundation and metal siding.**
- ii. North entry door not closing properly.**
- iii. Rust on metal roll up doors and frame.**
- iv. “stained area” of insulation on exterior wall near AC unit that requires investigation of cause and correction**

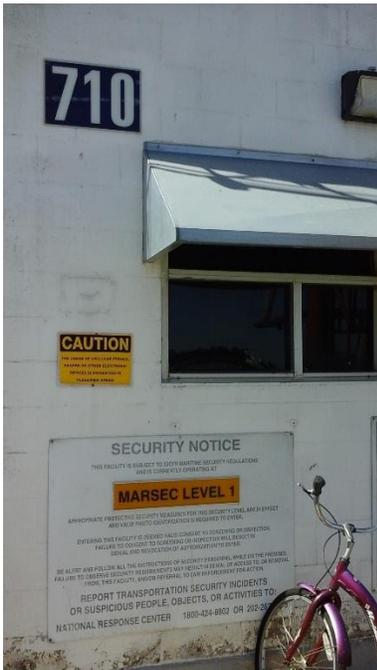
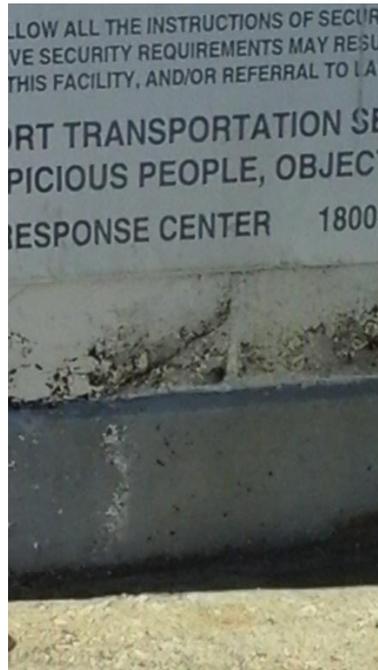
6. Building 710 (Operation Control Dock 1)

- i. Rust on doors, door frames and window frames.
- ii. Mold on exterior surfaces.
- iii. Rust on dock railings.

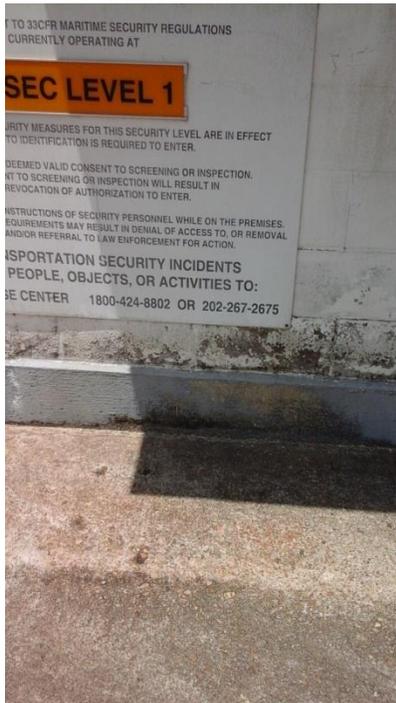
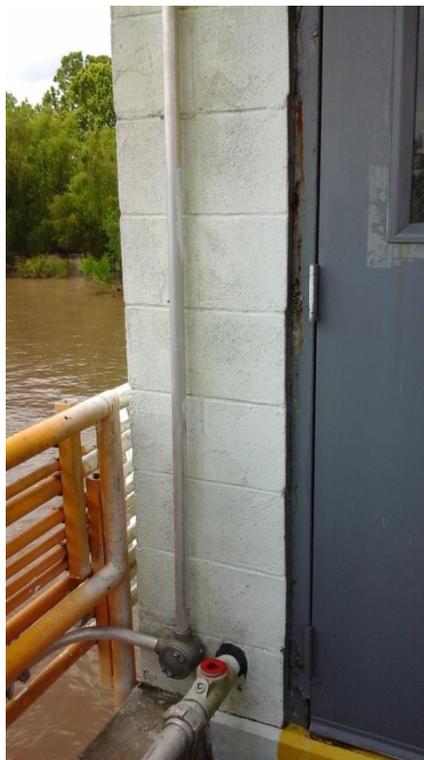
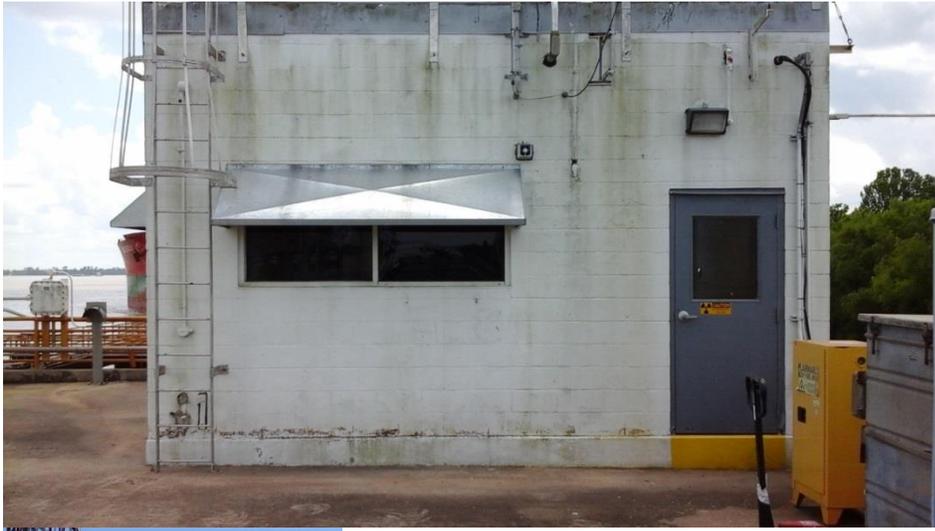
7. Building 713 (Operation Control Dock 2)

- i. Rust on exterior doors, door frames and window frames.**
- ii. Mold on exterior surfaces**
- iii. HVAC and positive pressure unit not working.**

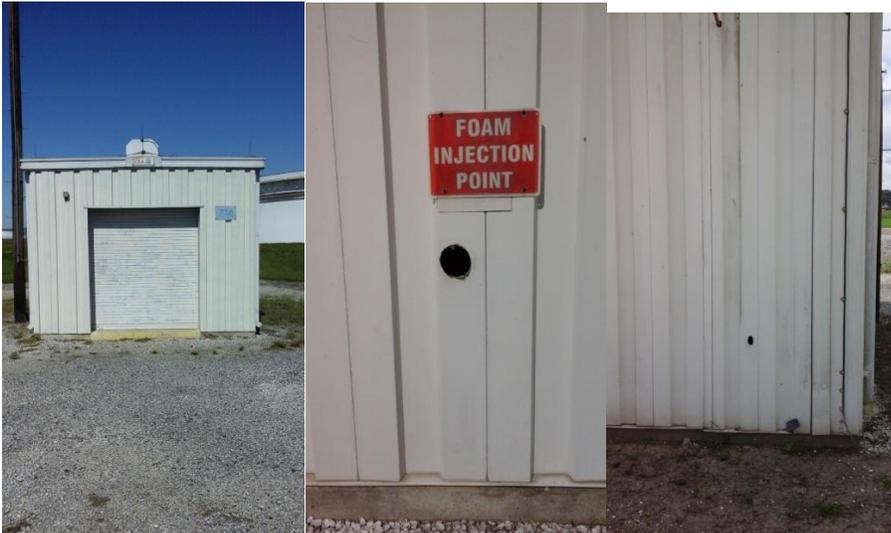
8. Building 714 (Foam Deluge)

- i. Partially missing insulation.**
- ii. Residue of flood water inside building.**

- i. Oxidized paint on exterior surfaces**
- ii. Building signage faded.**
- iii. Two holes in siding**

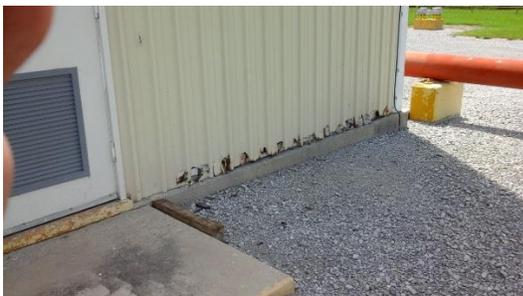
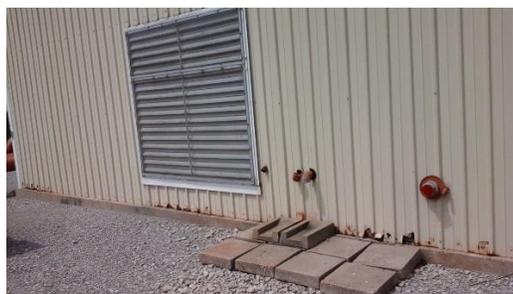
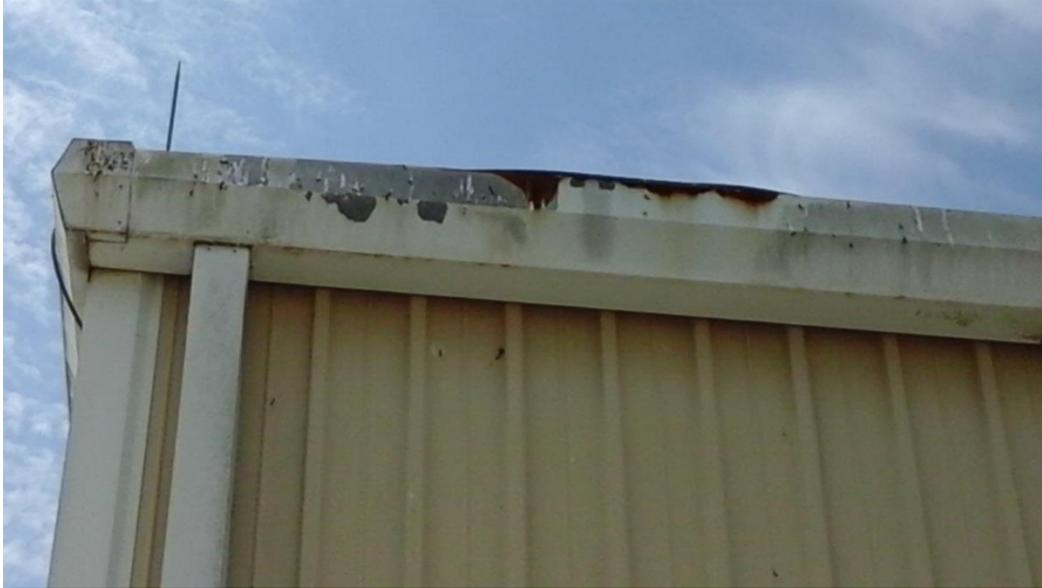
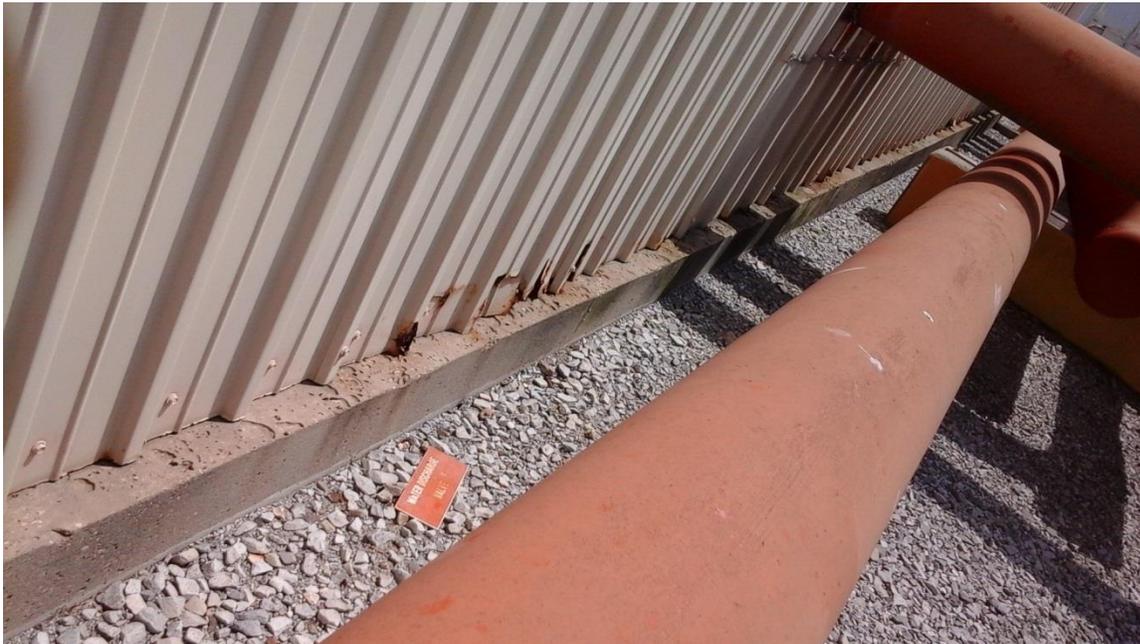
- i. Pump's packing leaking water.**

- i. Rust at foundation.**
- ii. Oxidized paint on exterior stairs to fuel intake.**
- iii. Rust and oxidized paint on wall, window frames and gutter.**

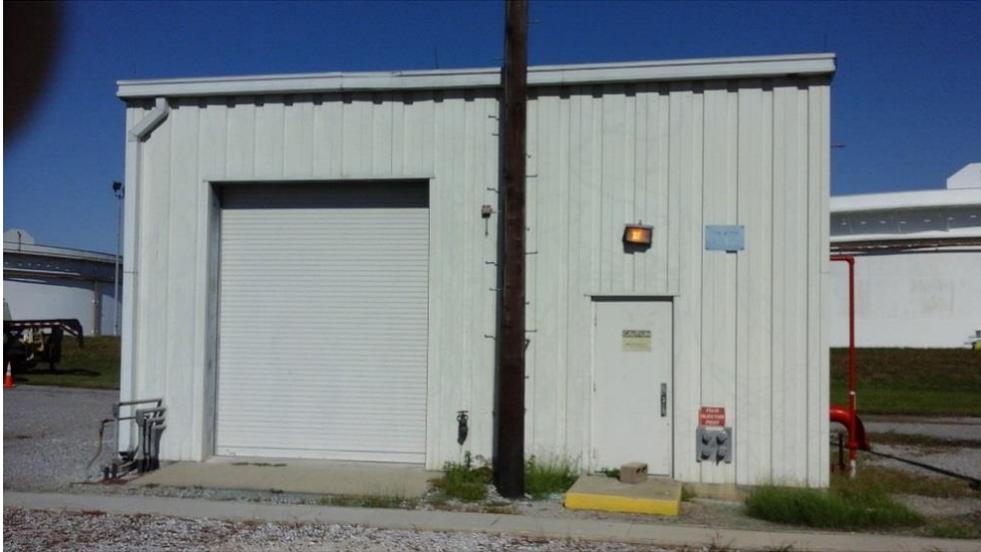
11. Building 717 (Foam Deluge)

- i. Oxidized paint on exterior walls and gutters.**
- ii. Building number signage faded.**

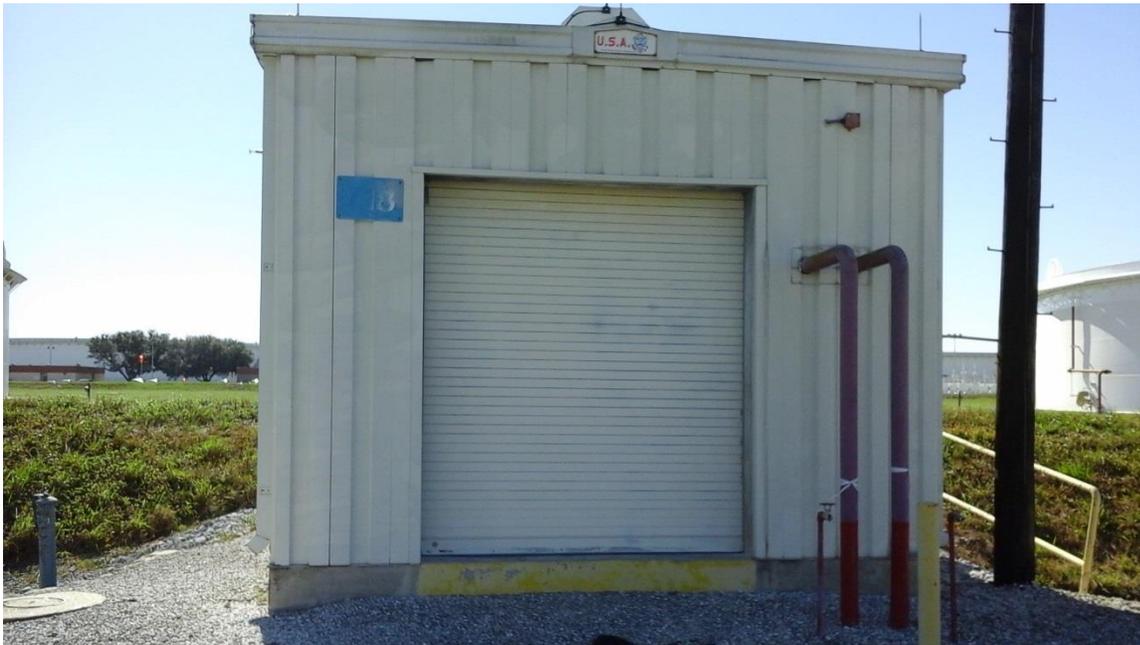
12. Building 718 (Foam Deluge)

- i. Oxidized paint on exterior walls and gutters**
- ii. Building number signage faded.**

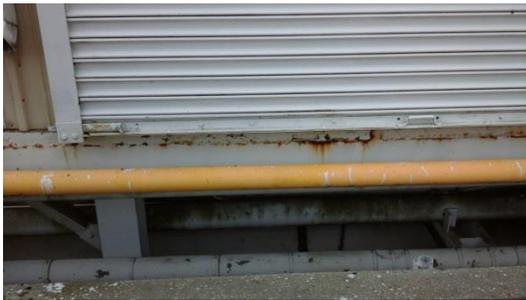
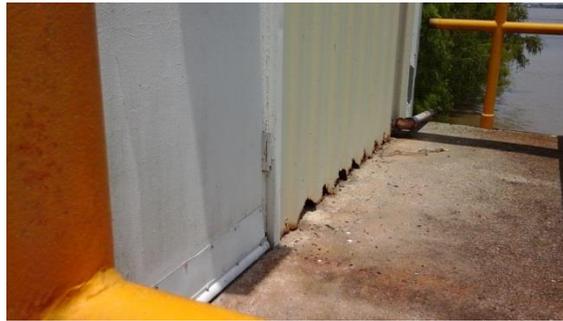
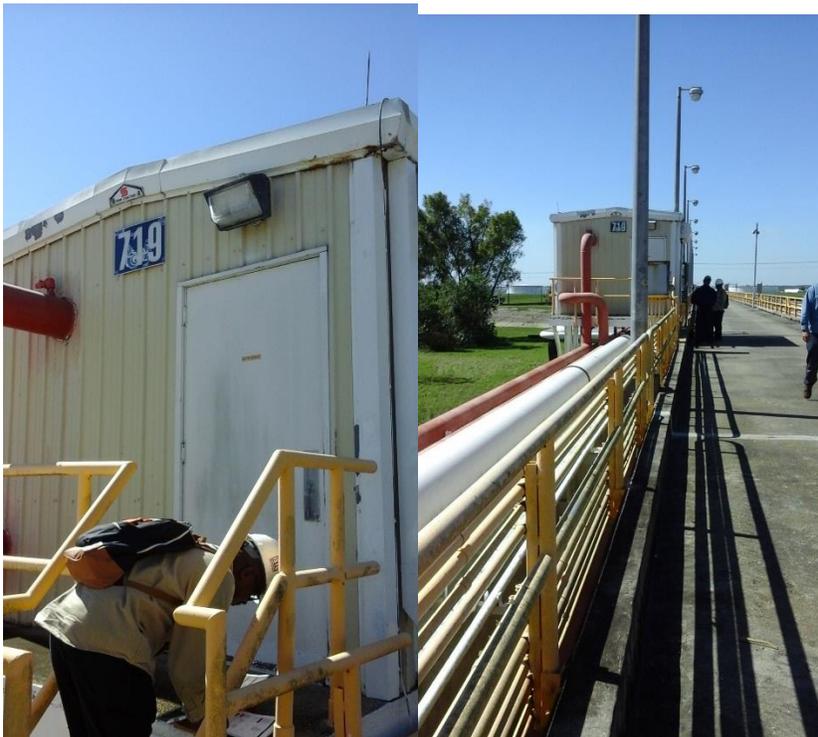
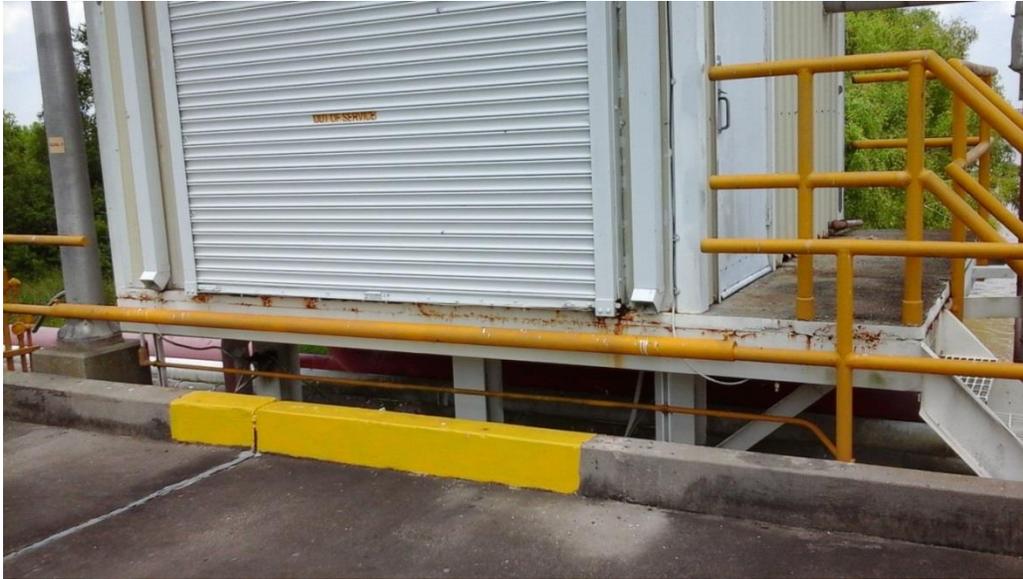
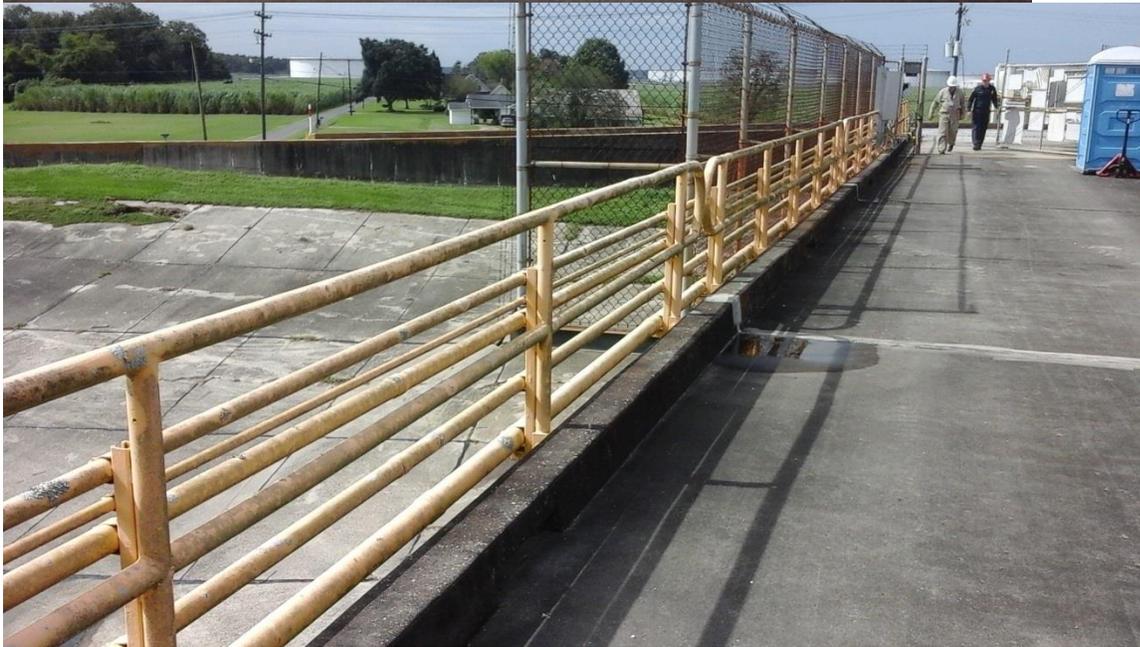
13. Building 719 (Foam pump on Dock 1)

- i. Oxidized paint on exterior walls and gutters**
- ii. Rust and green algae/moss on railings located on docks 1 and 2.**

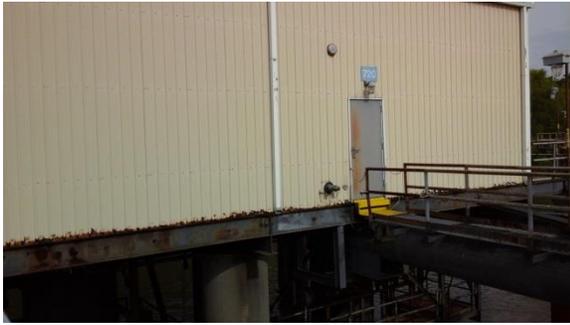
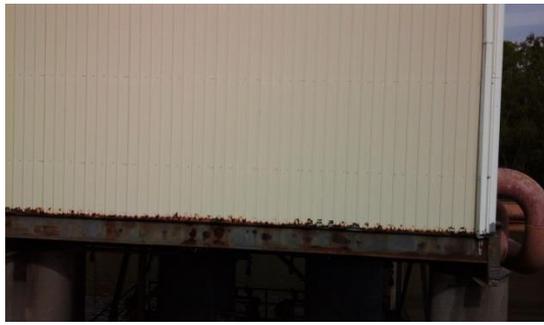
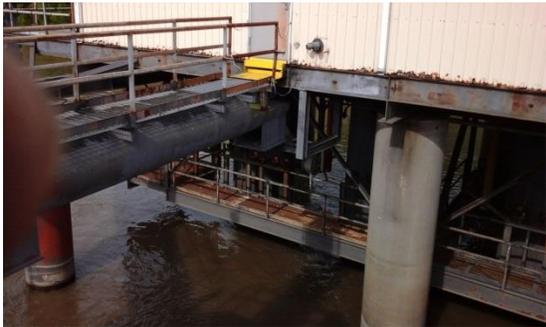
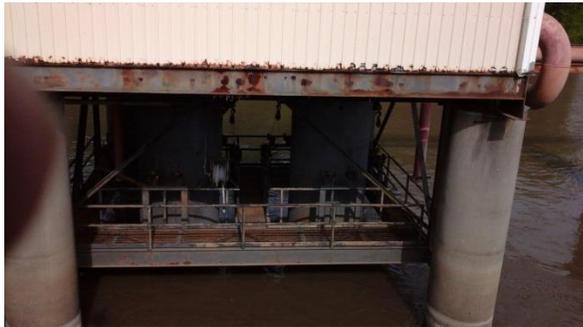
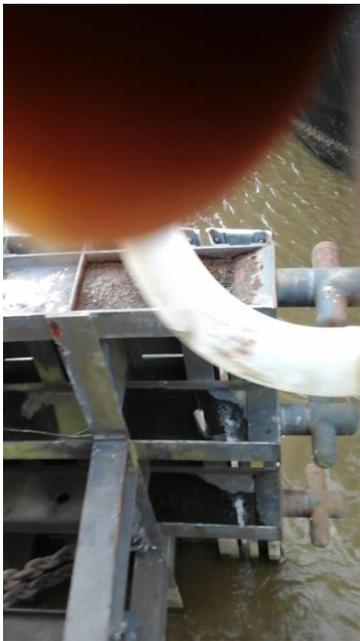
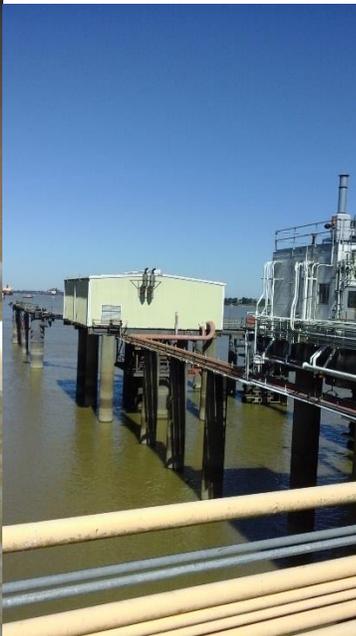
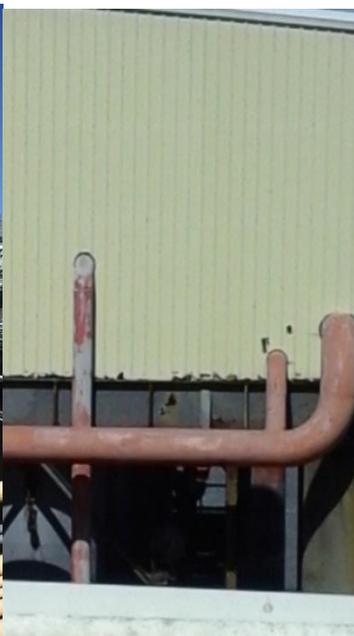
14. Building 720 (Fire Water Pump House on Dock 1)

- i. 1 to 3 inches of rust around the metal foundation.**
- ii. Rust on the doors and door frame, metal foundation, support beams, and metal catwalks.**
- iii. Oxidized paint exterior walls, doors, and frames.**

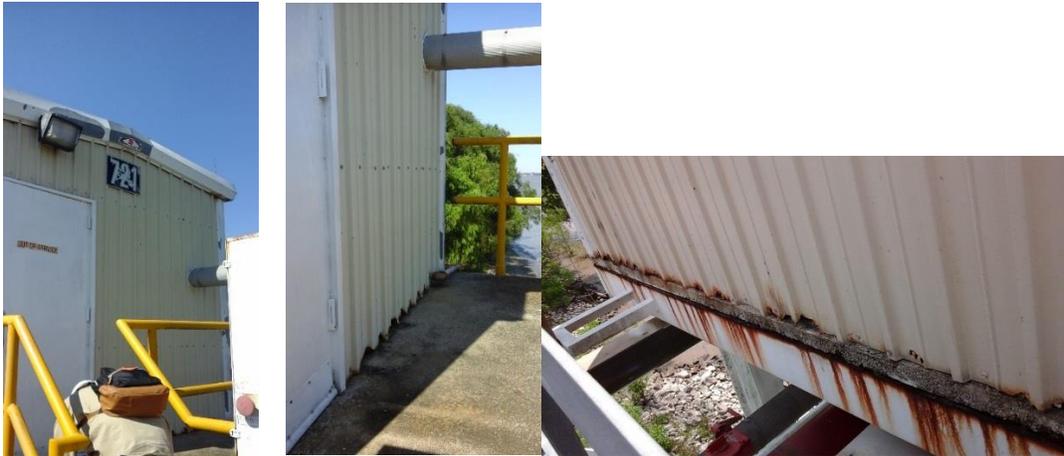
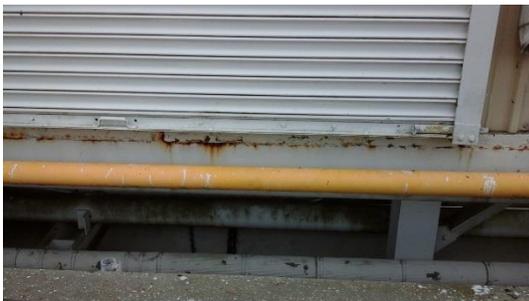
15. Building 721 (Foam pump on Dock 2)

- i. Rust on siding and foundation.**
- ii. Oxidized paint on exterior walls.**

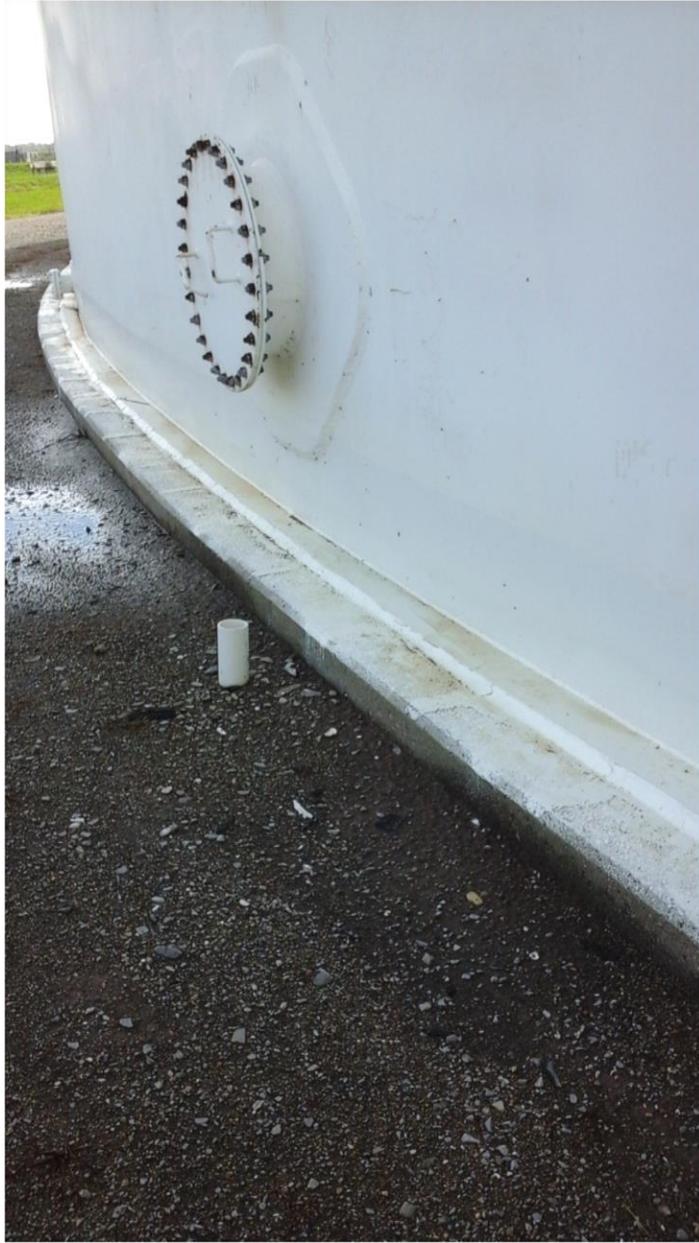
- 1) All tank chimes were caulked and painted to approximately one foot high on side of tank. This prevents water from seeping under the chime and causing rust. The chimes needed repainting and Shell performed this on all six tanks.

Chimes caulked and painted on all tanks

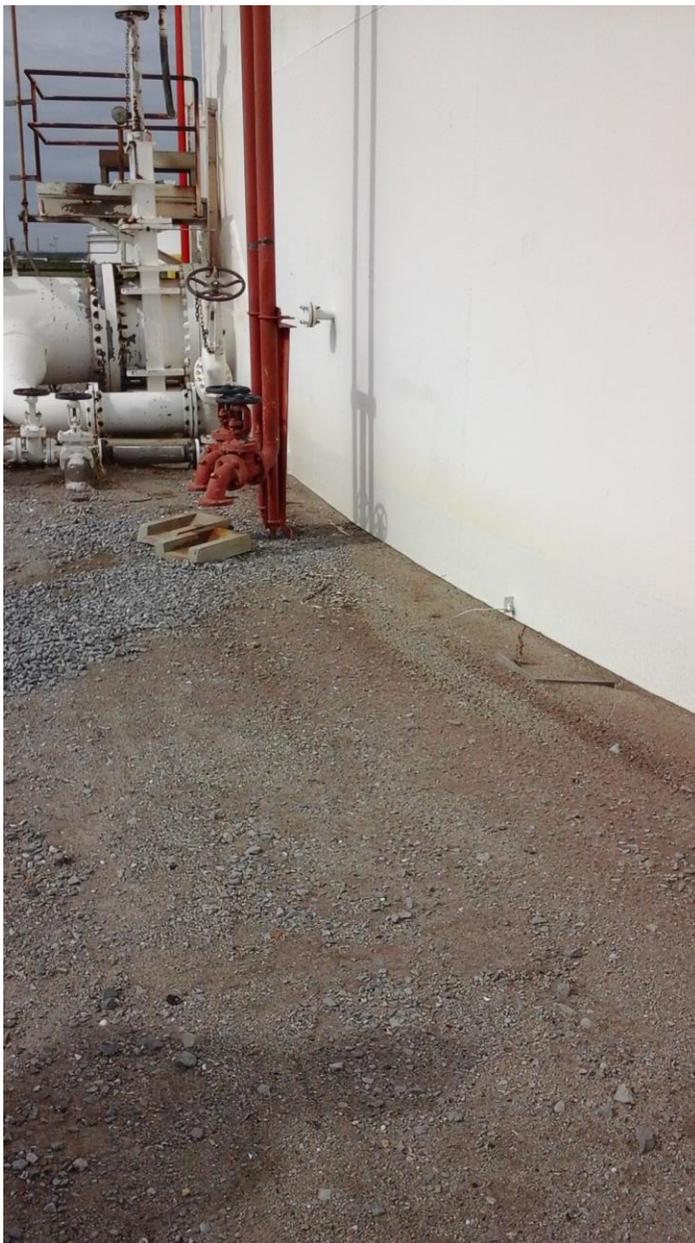
- 1) Tank 5 has excessive limestone over chime and ring wall preventing any type of evaluation and water to be trapped against tank shell causing corrosion. Gravel needs to be sloped away from tank to allow drainage. Discussed with site who stated they were waiting till after the fire protection work is completed and estimated this would be done in January/February 2019 timeframe.

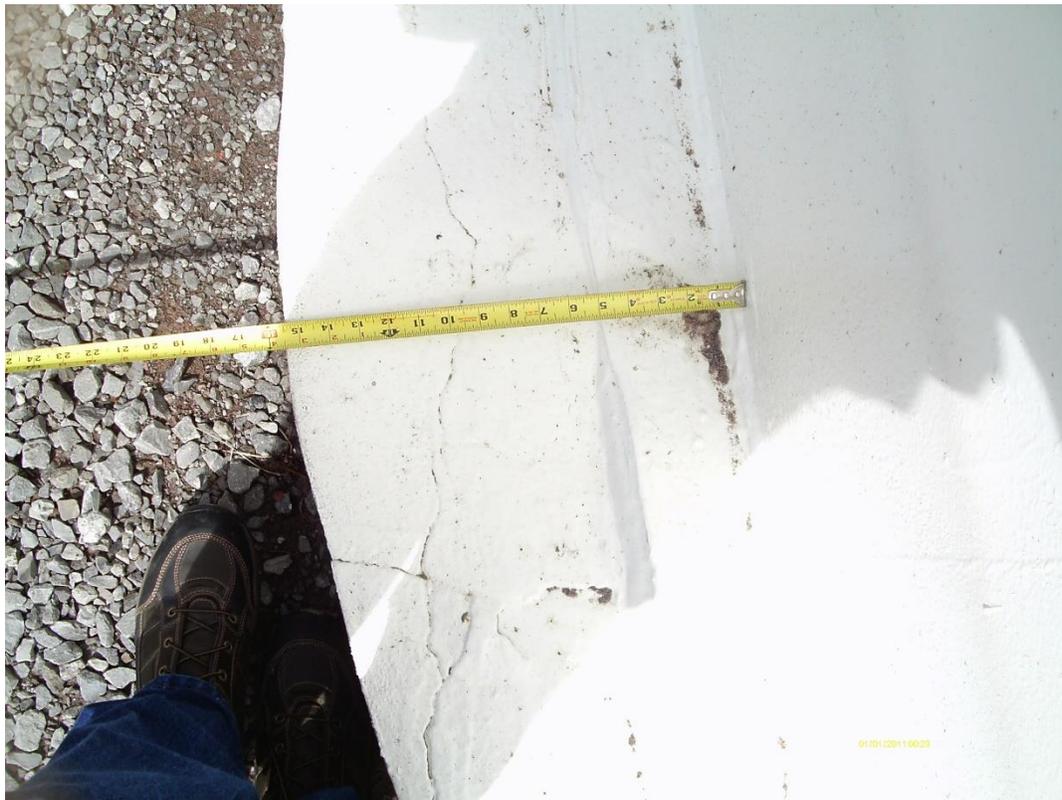
The repaired chain wall area of tank 2 was measured in 2017 at 15.5 inches out from the tank wall. This is being tracked in case the concrete repaired area starts pushing out. This was measured in 2018 as the same 15.5 inches (see photo). This shows no pushing out for last year period but this will continue to be tracked in future audits.

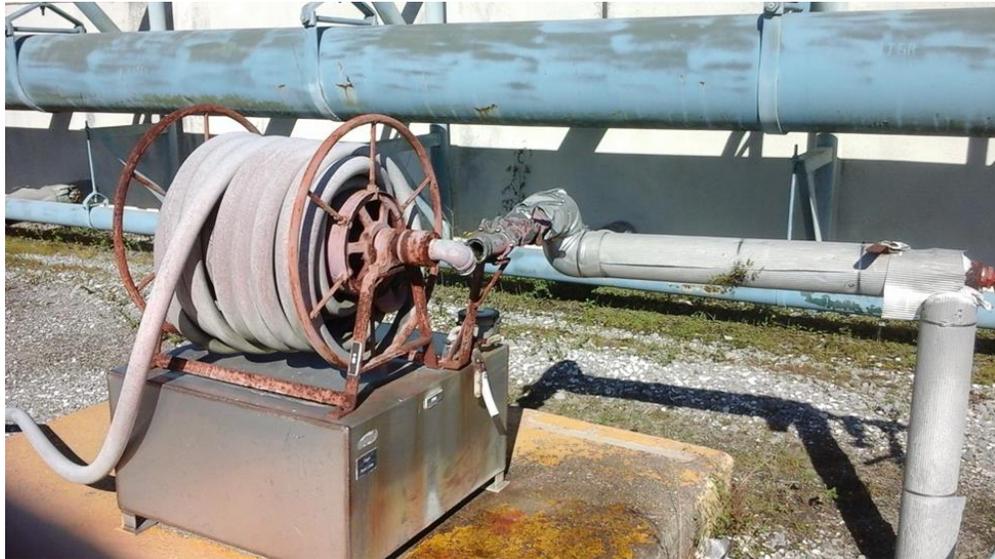
- **Foam/fire house for FPU#5 is out-of-service with broken connection supply. Needs to be reconnected or removed.**

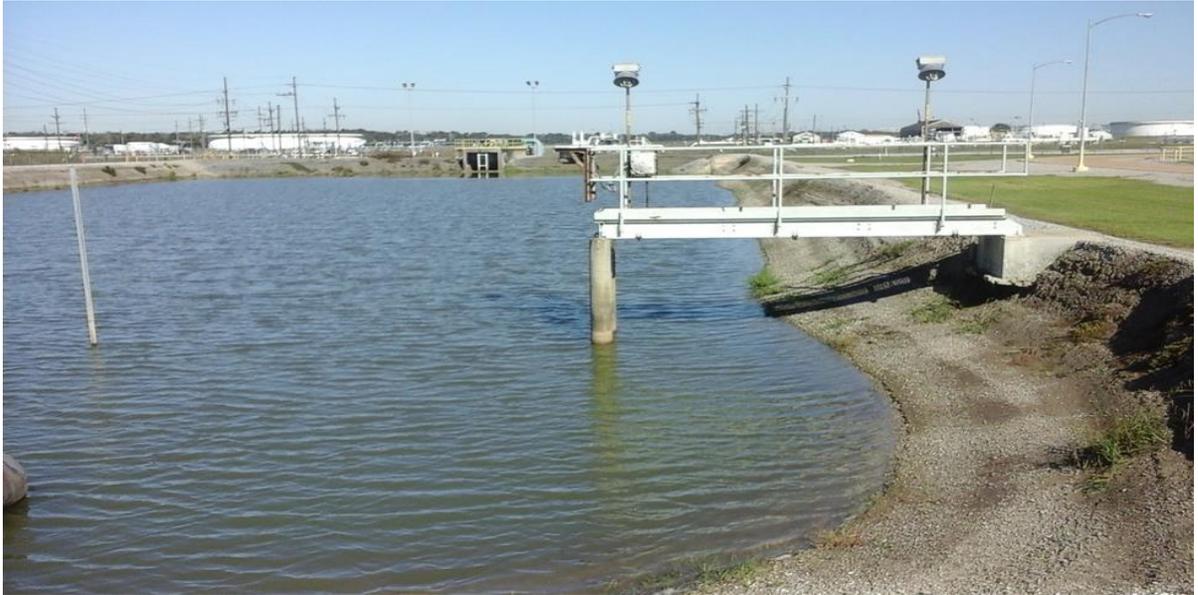
- **Retention pond has civil erosion on dike area. Walkway to oil spill detector unit may have structural foundation issues.**

Needs fill material added under concrete structure to prevent collapse.
