U.S. DEPARTMENT OF ENERGY
Strategic Petroleum Reserve
Project Management Office
New Orleans, Louisiana

**SHELL PIPELINE COMPANY LP
FY 2018 ANNUAL LEASE
PERFORMANCE EVALUATION OF THE
ST. JAMES (SUGARLAND) TERMINAL
(DE-RL96-97PO70010)**

October 24 & 25, 2018

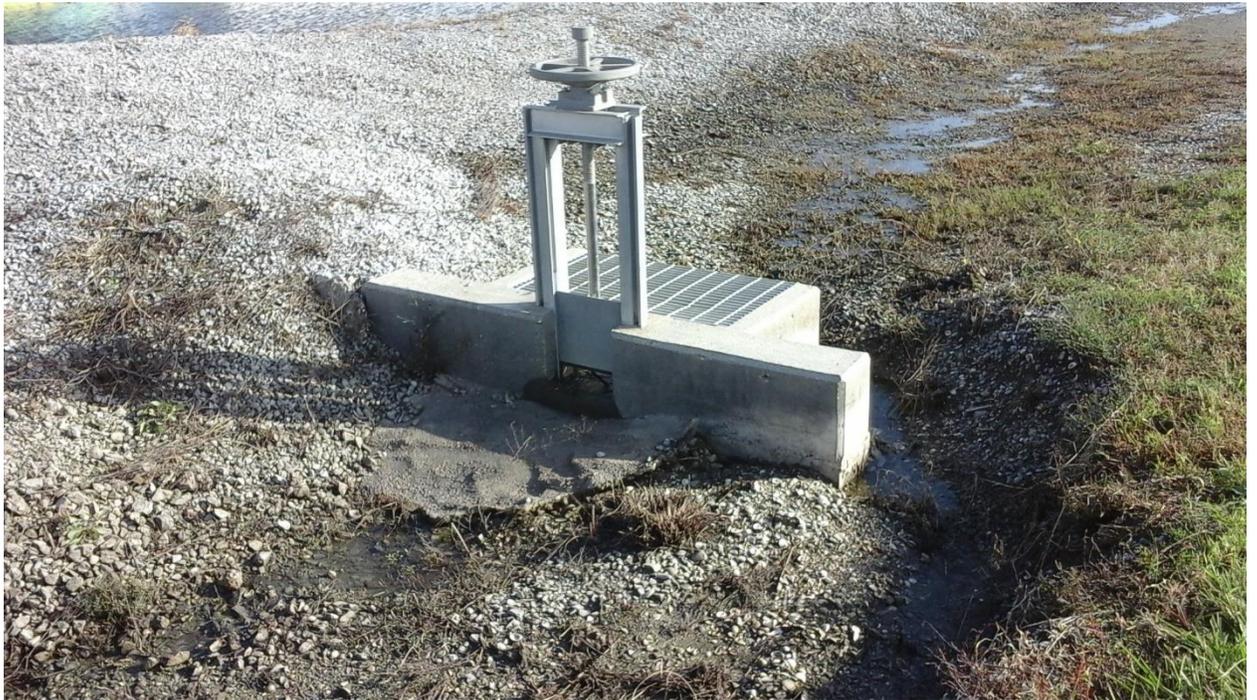
- **Storm water sludge gate near oily water separator south side of terminal has civil erosion around bulkhead rendering the gate operation ineffective. Area needs to be backfilled with material.**

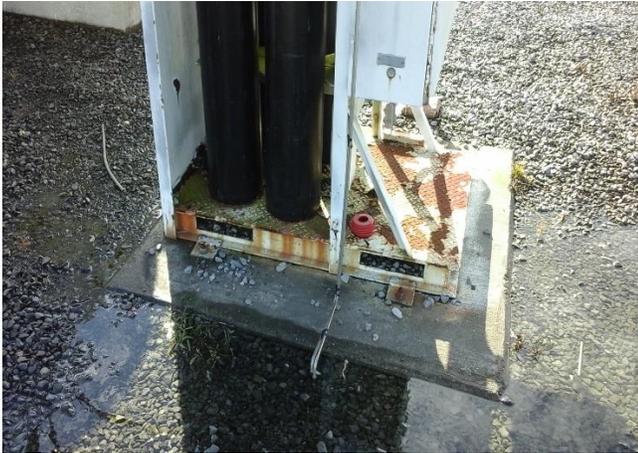
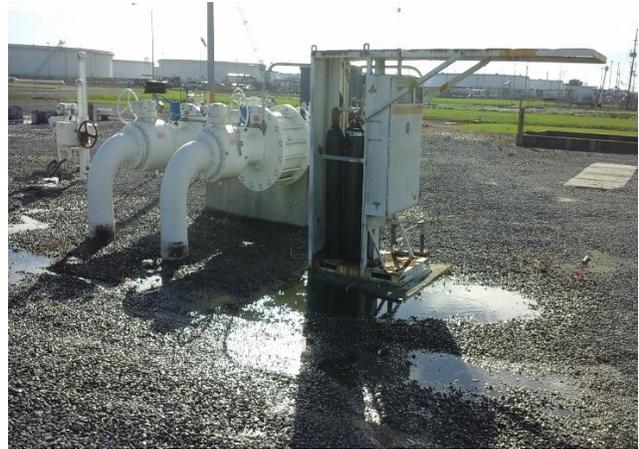
- **Red stick pipeline surge relief cabinet has failed paint coating at bottom. Requires coating repair.**

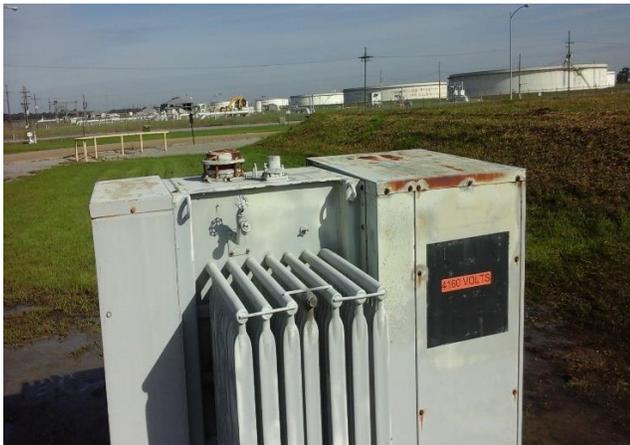
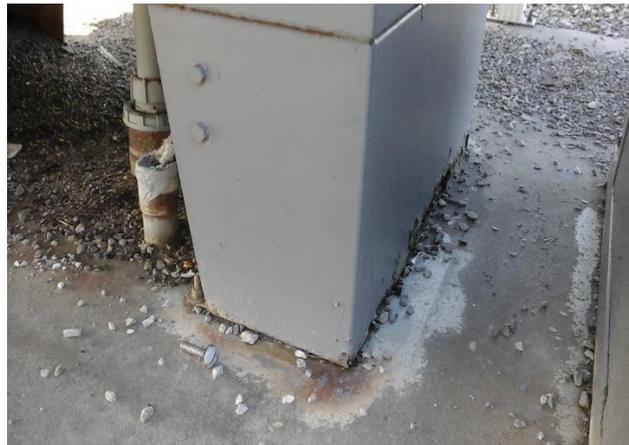
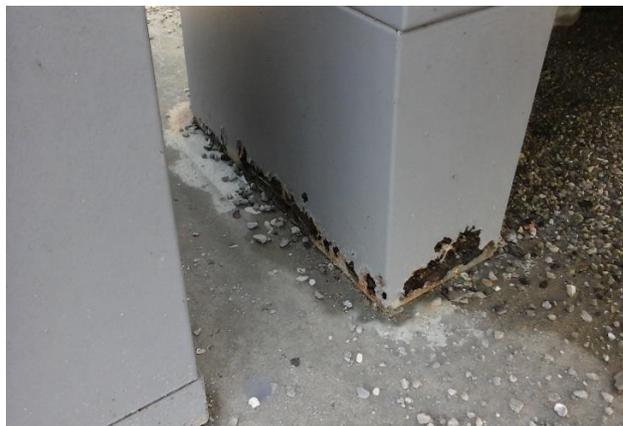
- **RTU 7 shows signs of failed paint coating at top and bottom of cabinet and support components.**

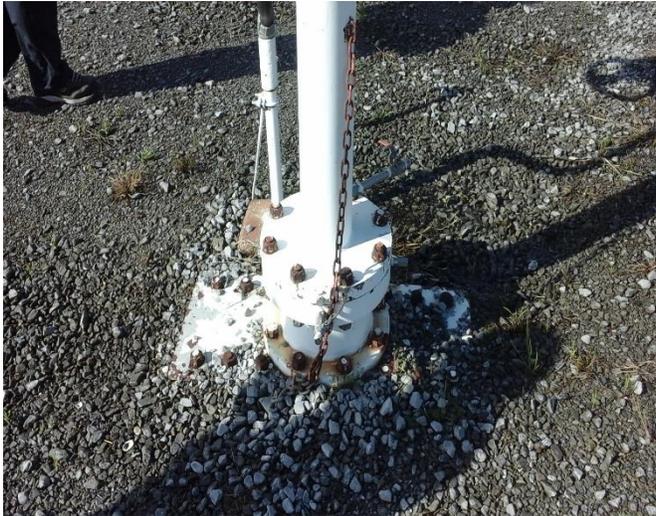
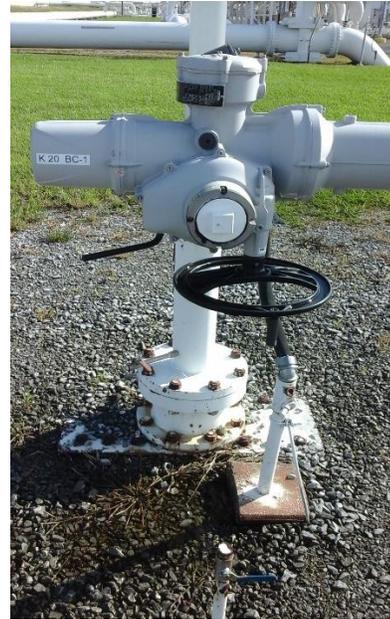
- **MOV K20BC1 shows failed paint coating (rusted bolts/nuts) on stem/bonnet area.**

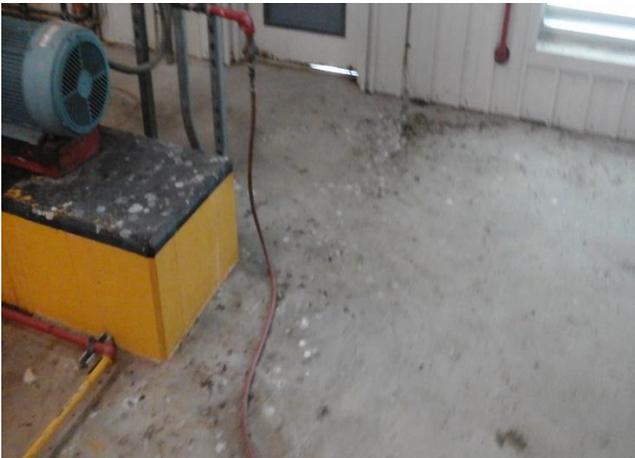
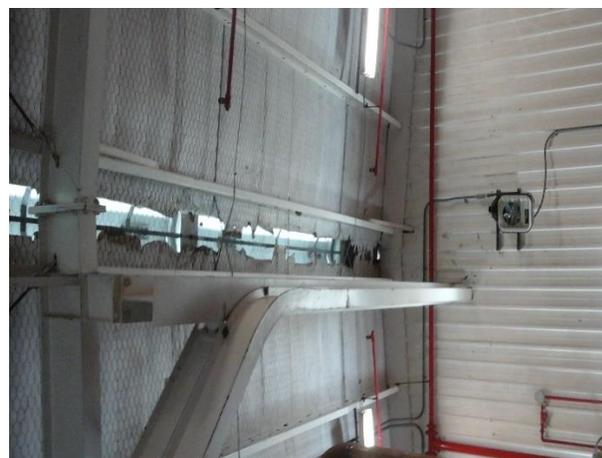
- **Significant bird dropping inside fire water pump house. Appears to be caused by nesting birds due to opening in varmit screen near roof. Repair hole in screen and wash down area.**

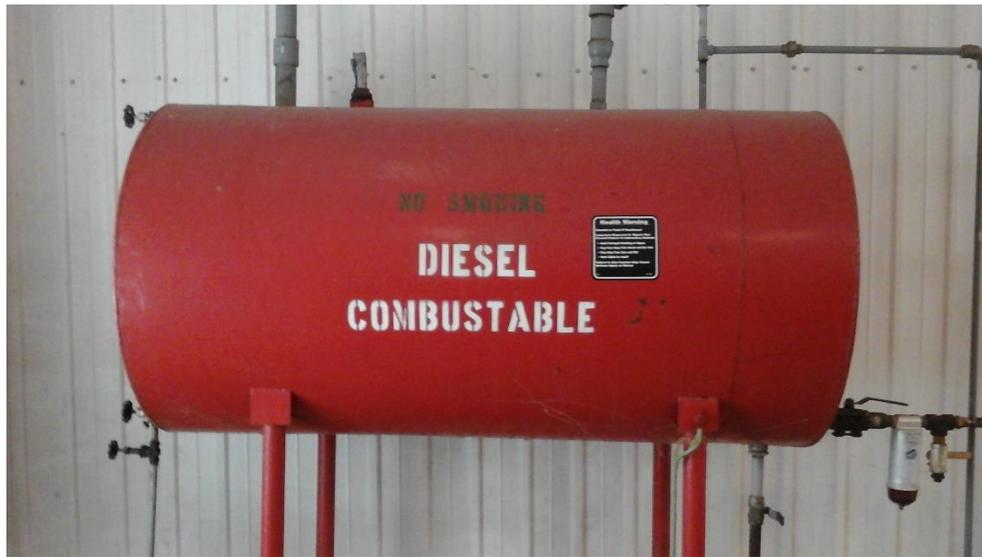
- **Diesel tank inside main fire water pump house has improper (tape & paper) device inserted in tank vent hole at top of tank. Screen previously existed.**

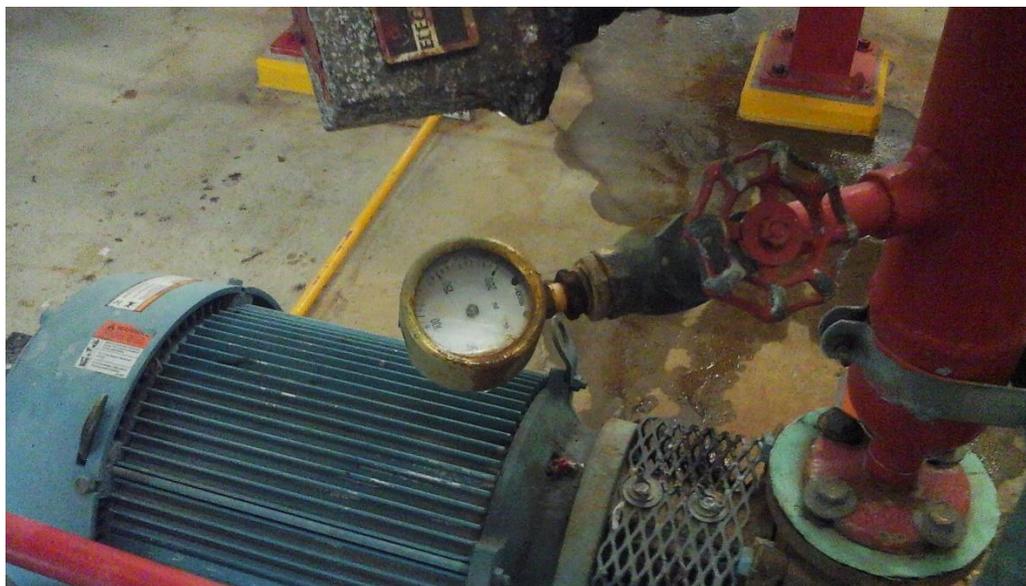
- **Several local pressure gauges on fire system inside fire water pump house are broken/inoperable.**

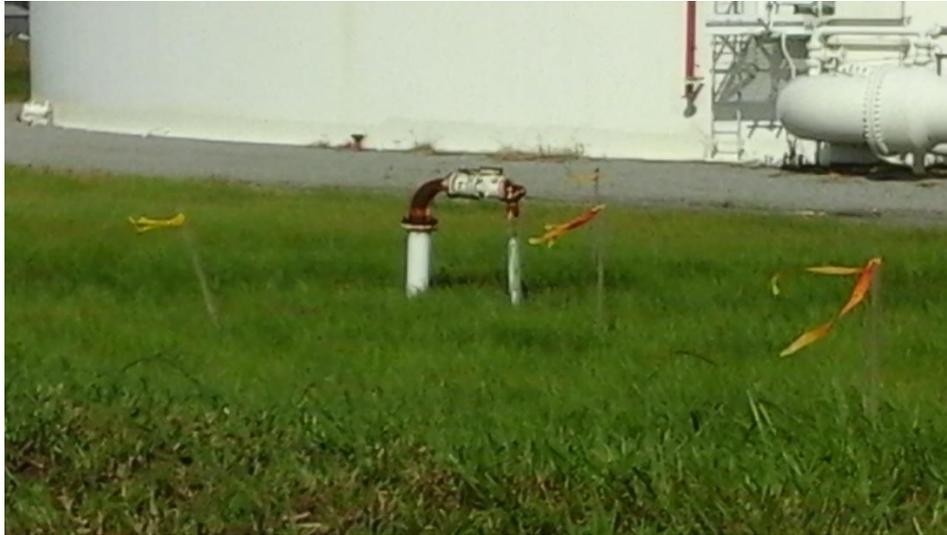
- **Stripper line connection riser inside Tk3 dike shows signs of paint failure.**

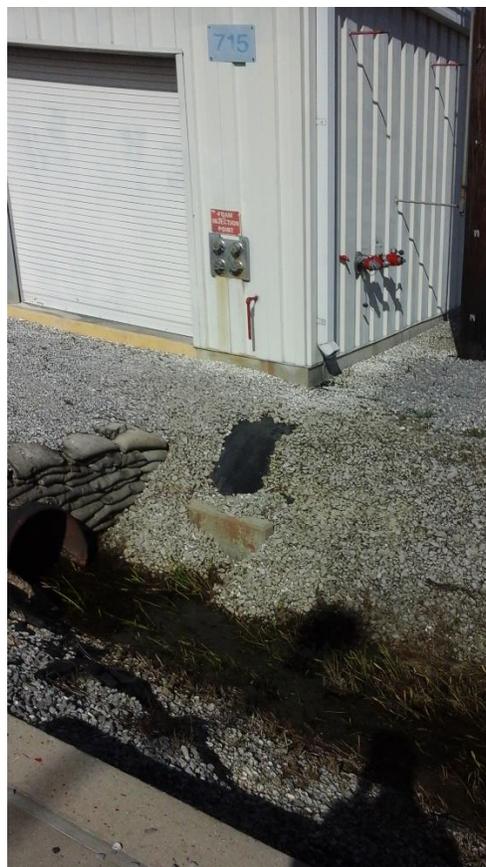
- **Ground/civil erosion outside front of foam building #715**

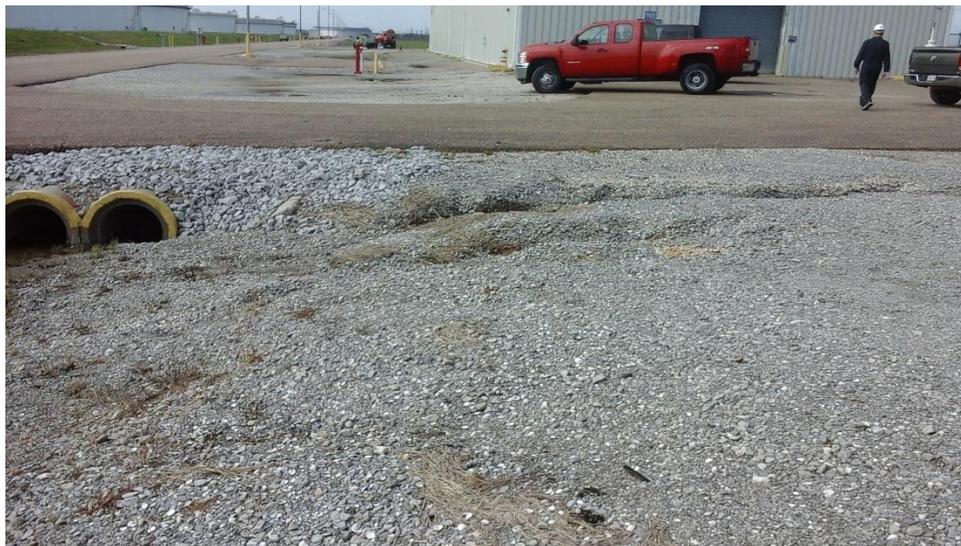
- **Civil/ground erosion near culvert between #708 flammable building and warehouse area.**

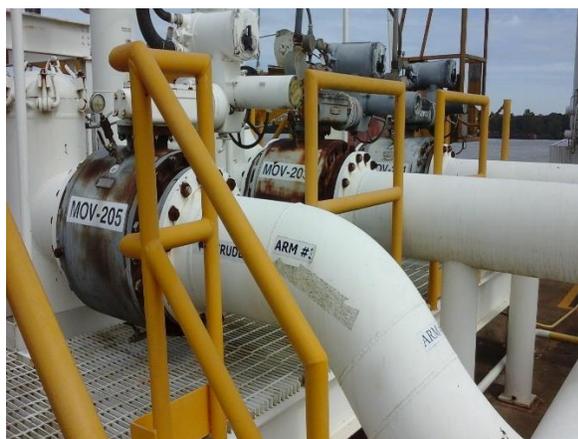
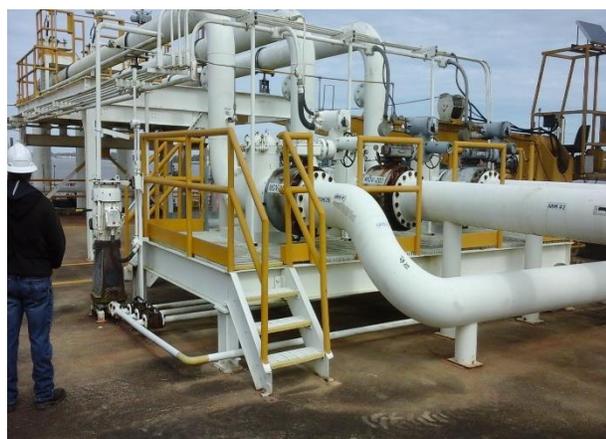
- Dock #2 MOV's 205, 203 need paint coating.

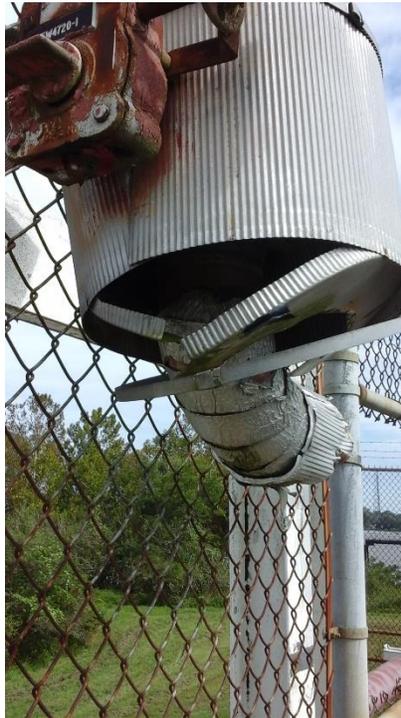
- **Dock #2 FW4720-1 fire water valve insulation to be resecured or replaced.**

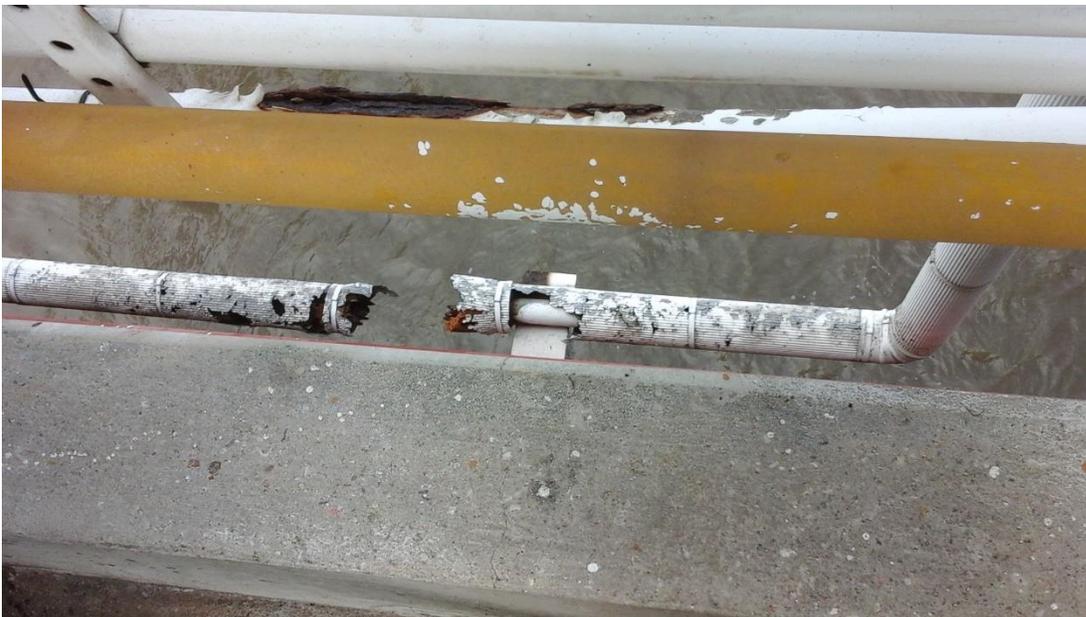
- **Dock #1 2" potable water line on north side of control building is completely severed/corroded in two. Needs repair or replacement.**

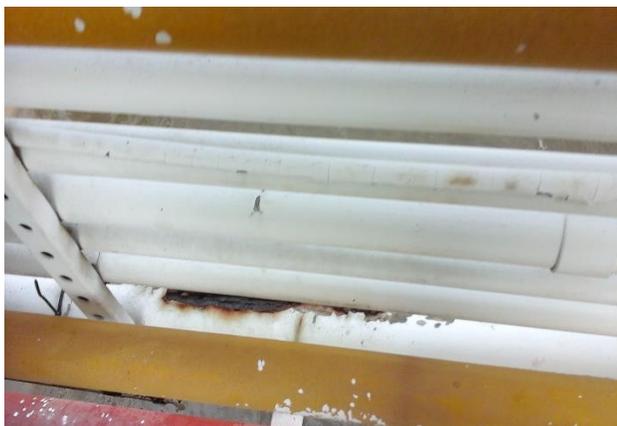
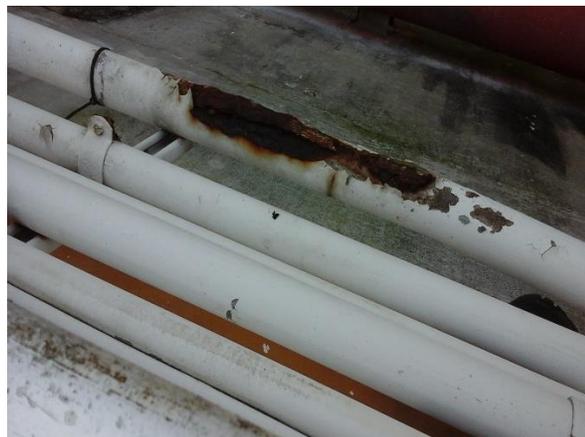
- Dock #1 electrical conduit on north side of control building is significantly rusted/corroded.

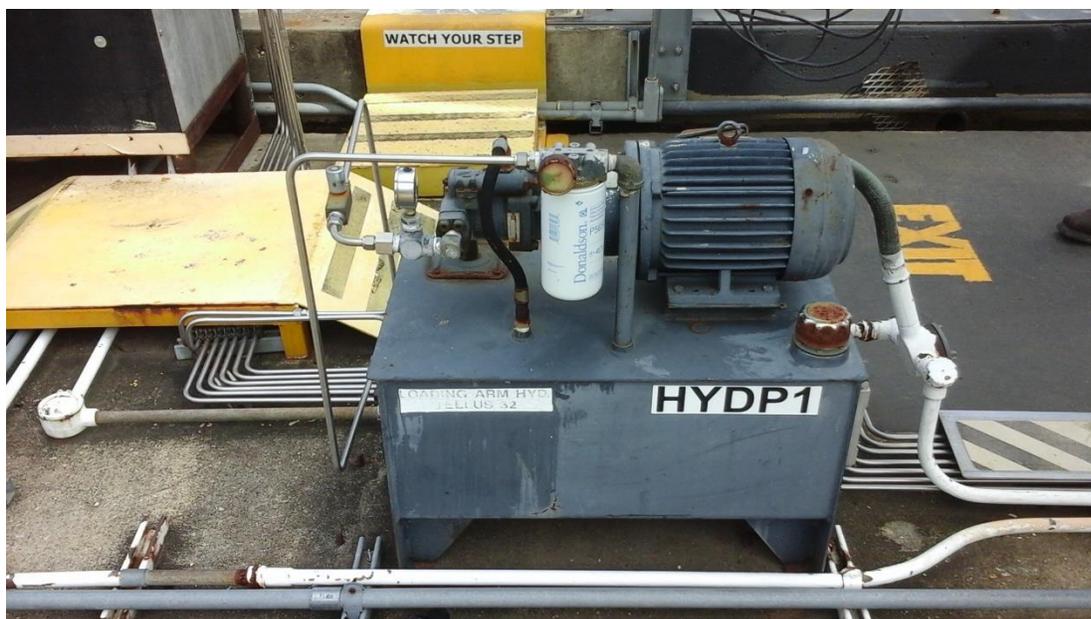
- Dock #1 loading arm hydraulic unit HYDPI has inoperable psi gauge.

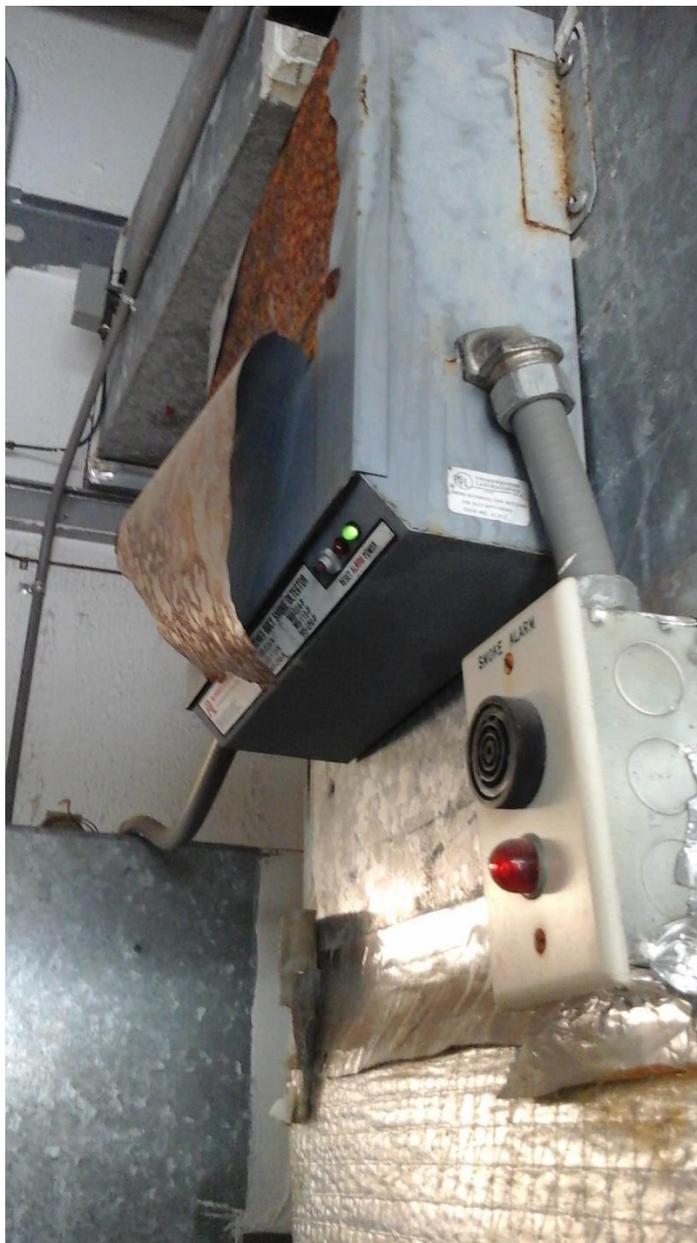
- Dock #1 control cabinet for smoke alarm inside control room has failed paint coating.
