**ATMOSPHERIC STORAGE TANK  
API 653 EXTERNAL & ULTRASONIC  
IN-SERVICE INSPECTION REPORT**

SHELL PIPELINE COMPANY, LP

TANK NO. 6

ST. JAMES TERMINAL

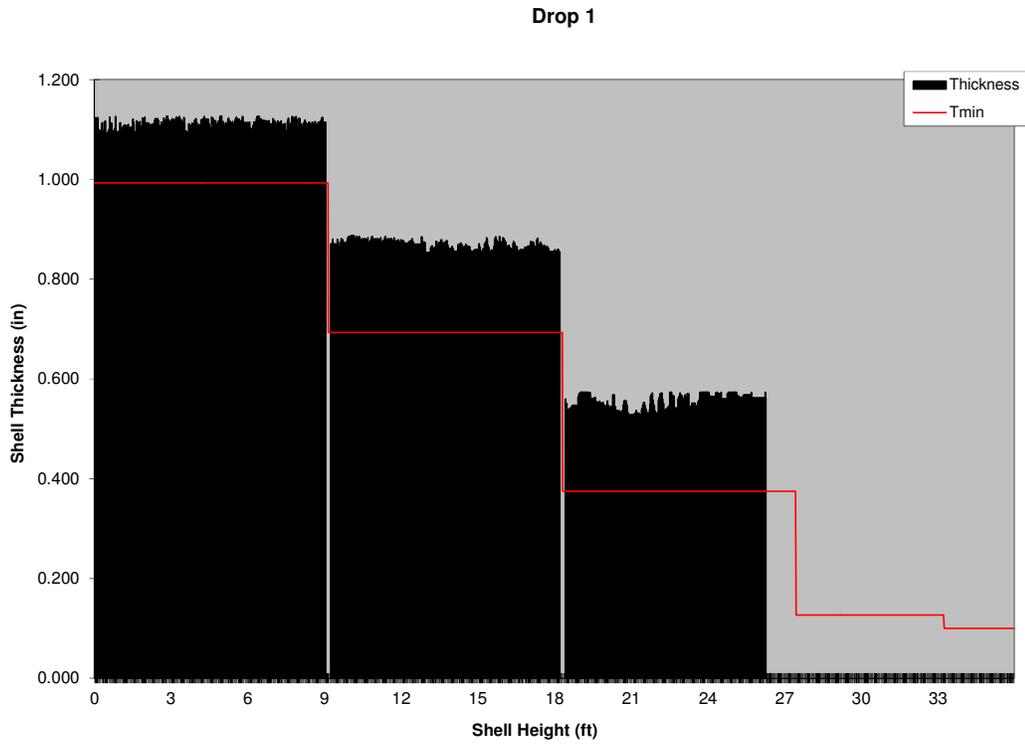
**DROP 1**

Drop 1	Min	Avg	Max
Course 1	1.087	1.109	1.127
Course 2	0.853	0.869	0.887
Course 3	0.528	0.555	0.573
Course 4	--	--	--

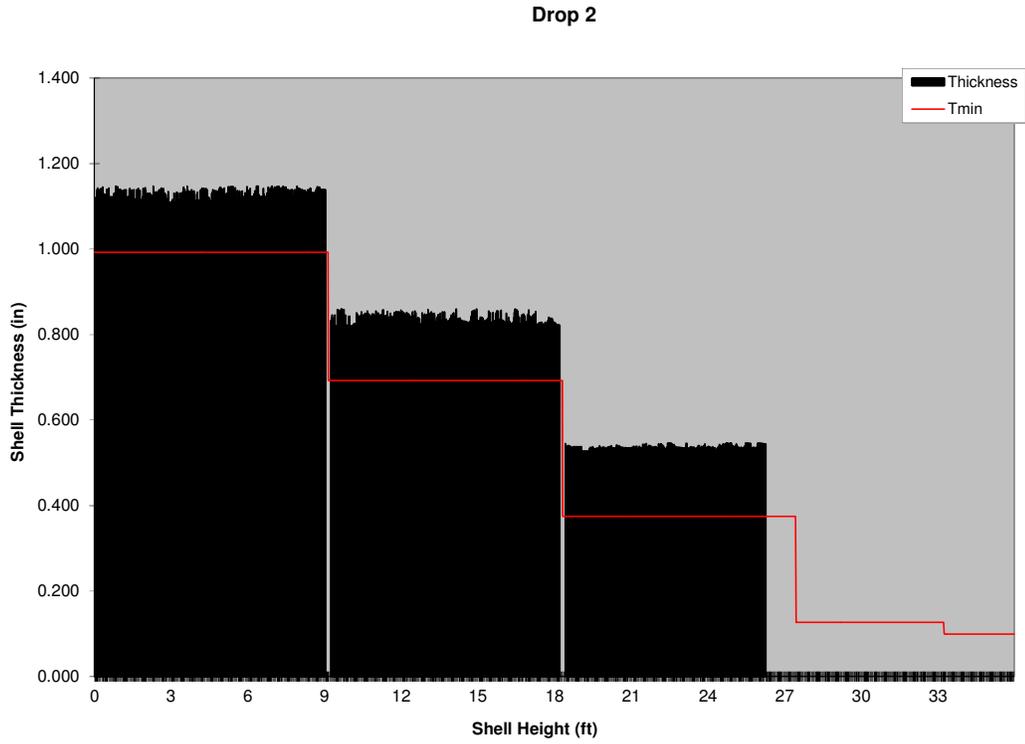
**DROP 2**

<b>Drop 2</b>	<b>Min</b>	<b>Avg</b>	<b>Max</b>
Course 1	1.108	1.130	1.147
Course 2	0.813	0.838	0.860
Course 3	0.527	0.537	0.547
Course 4	--	--	--

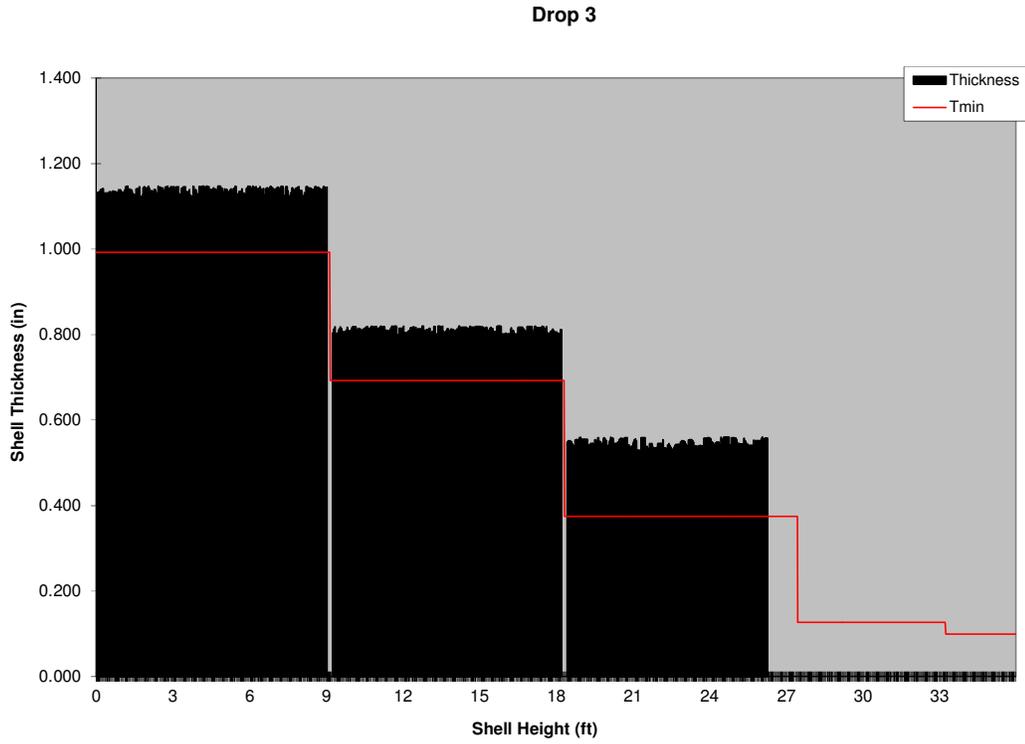
**DROP 3**

<b>Drop 3</b>	<b>Min</b>	<b>Avg</b>	<b>Max</b>
Course 1	1.121	1.137	1.147
Course 2	0.800	0.812	0.820
Course 3	0.527	0.547	0.560
Course 4	--	--	--

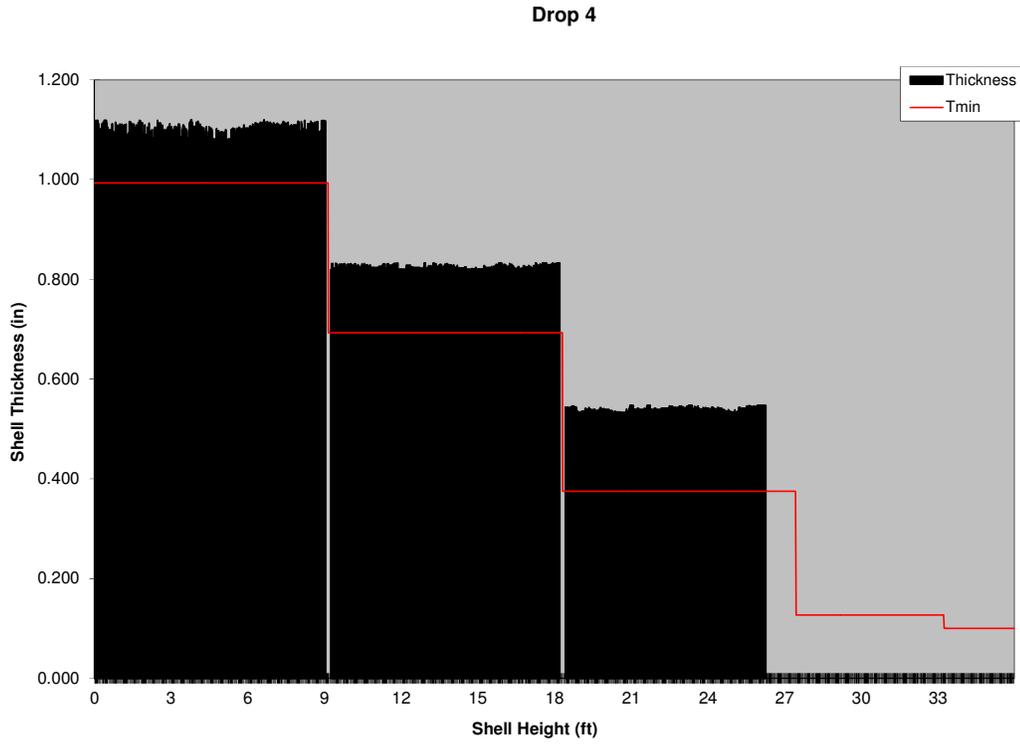
**DROP 4**

Drop 4	Min	Avg	Max
Course 1	1.080	1.101	1.120
Course 2	0.820	0.826	0.833
Course 3	0.533	0.540	0.547
Course 4	--	--	--

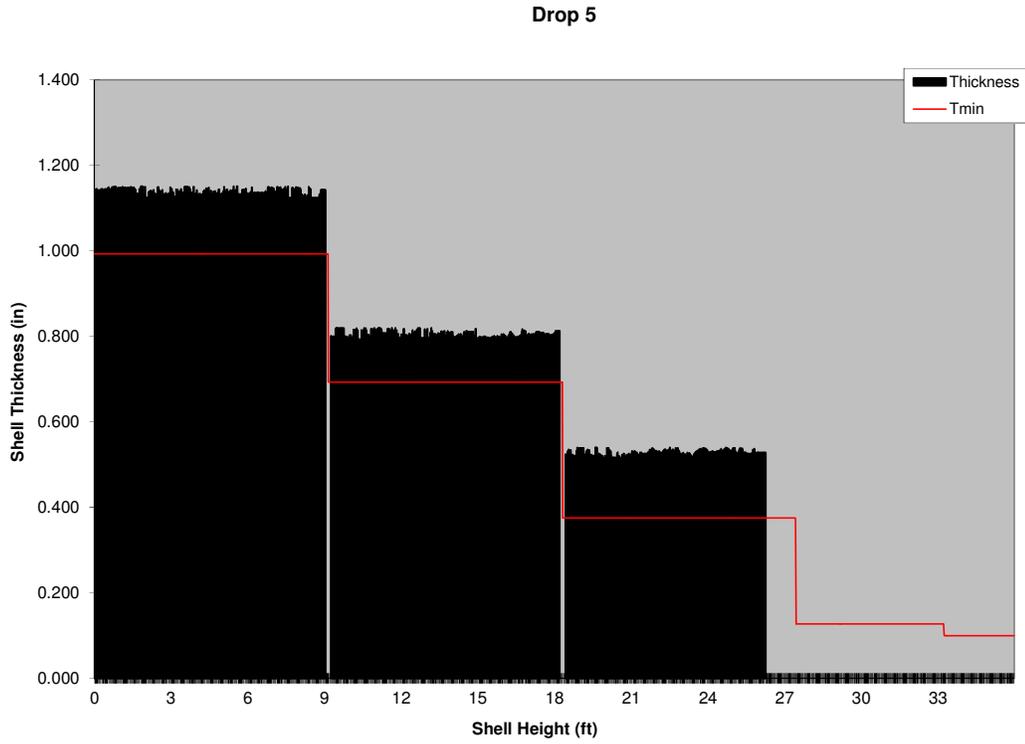
**DROP 5**

<b>Drop 5</b>	<b>Min</b>	<b>Avg</b>	<b>Max</b>
Course 1	1.113	1.138	1.151
Course 2	0.793	0.805	0.820
Course 3	0.516	0.529	0.540
Course 4	--	--	--

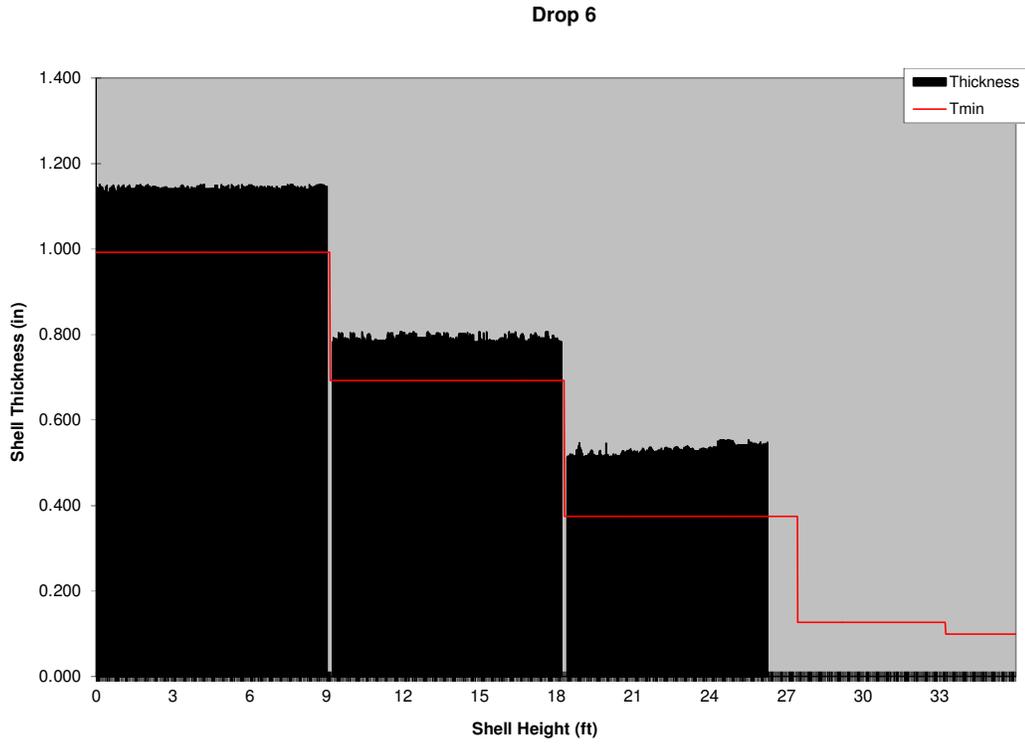
**DROP 6**

Drop 6	Min	Avg	Max
Course 1	1.127	1.144	1.151
Course 2	0.780	0.793	0.807
Course 3	0.513	0.531	0.553
Course 4	--	--	--

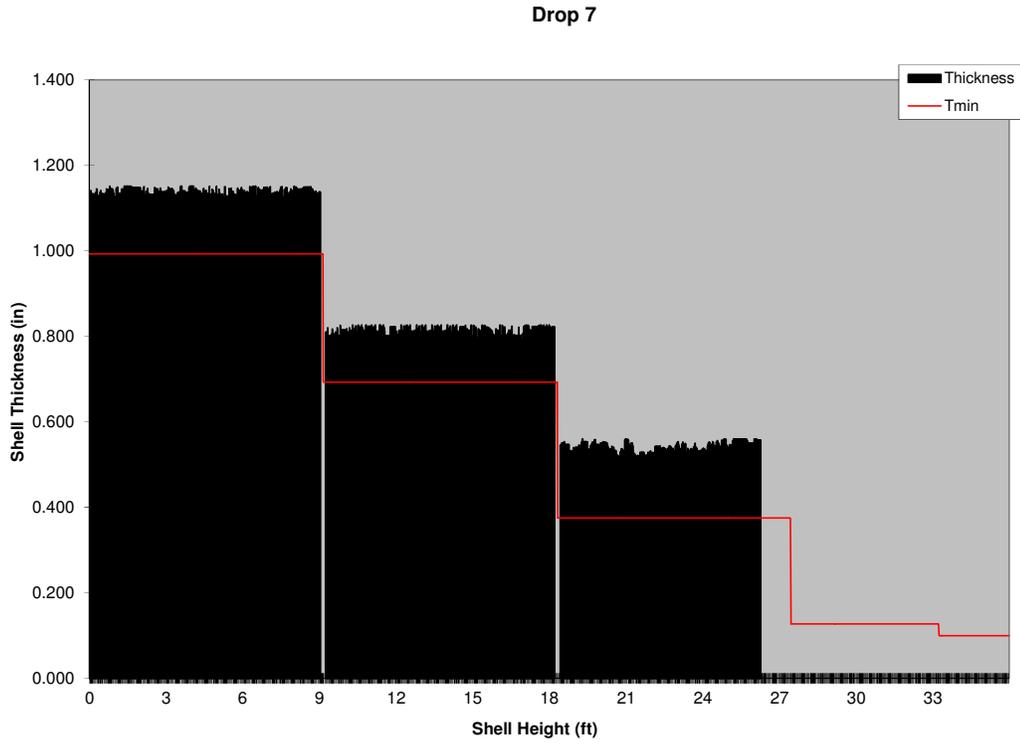
**DROP 7**

<b>Drop 7</b>	<b>Min</b>	<b>Avg</b>	<b>Max</b>
Course 1	1.127	1.140	1.151
Course 2	0.781	0.813	0.827
Course 3	0.516	0.542	0.560
Course 4	--	--	--

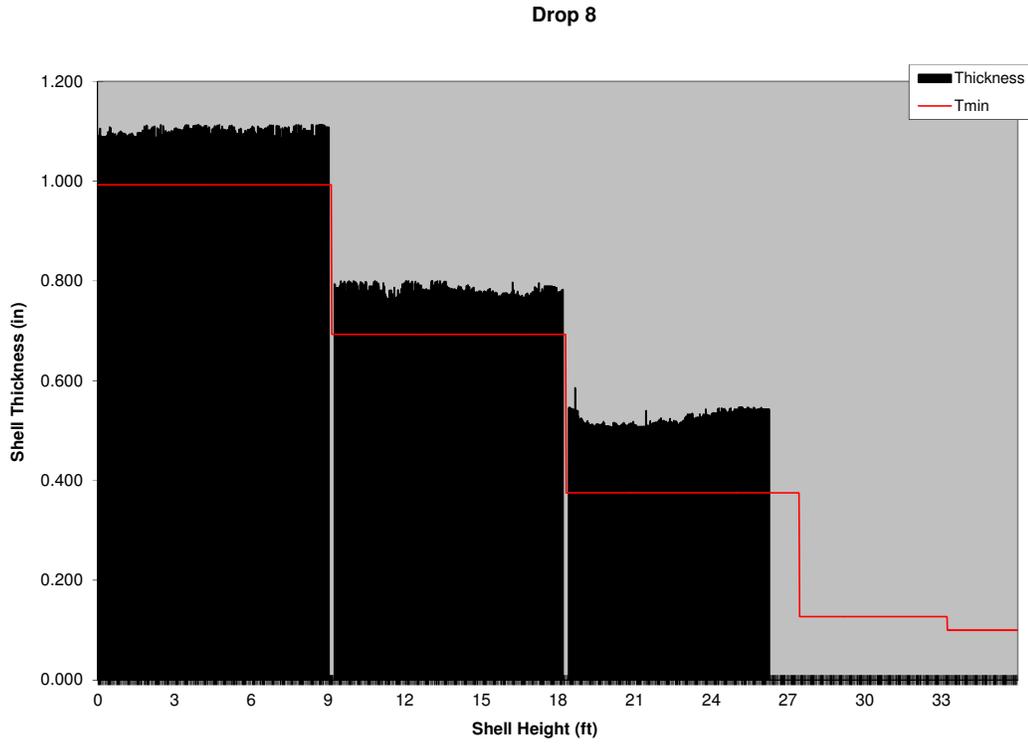
**DROP 8**

<b>Drop 8</b>	<b>Min</b>	<b>Avg</b>	<b>Max</b>
Course 1	1.087	1.100	1.113
Course 2	0.763	0.782	0.800
Course 3	0.507	0.525	0.586
Course 4	--	--	--

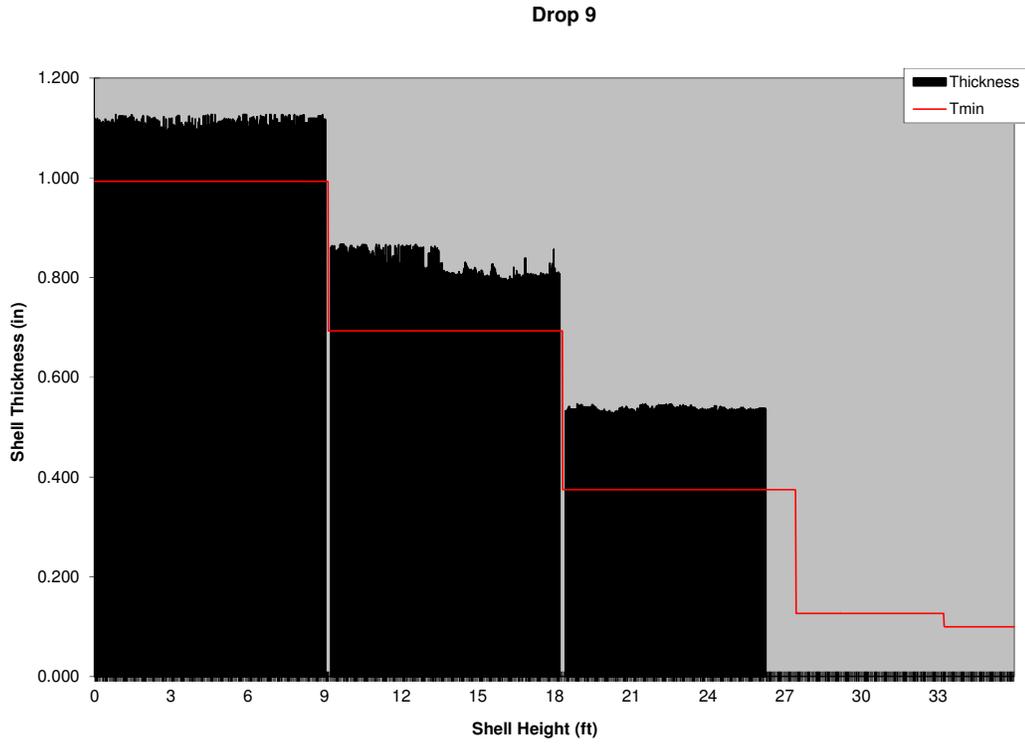
**DROP 9**

<b>Drop 9</b>	<b>Min</b>	<b>Avg</b>	<b>Max</b>
Course 1	1.093	1.113	1.127
Course 2	0.793	0.828	0.867
Course 3	0.527	0.537	0.547
Course 4	--	--	--

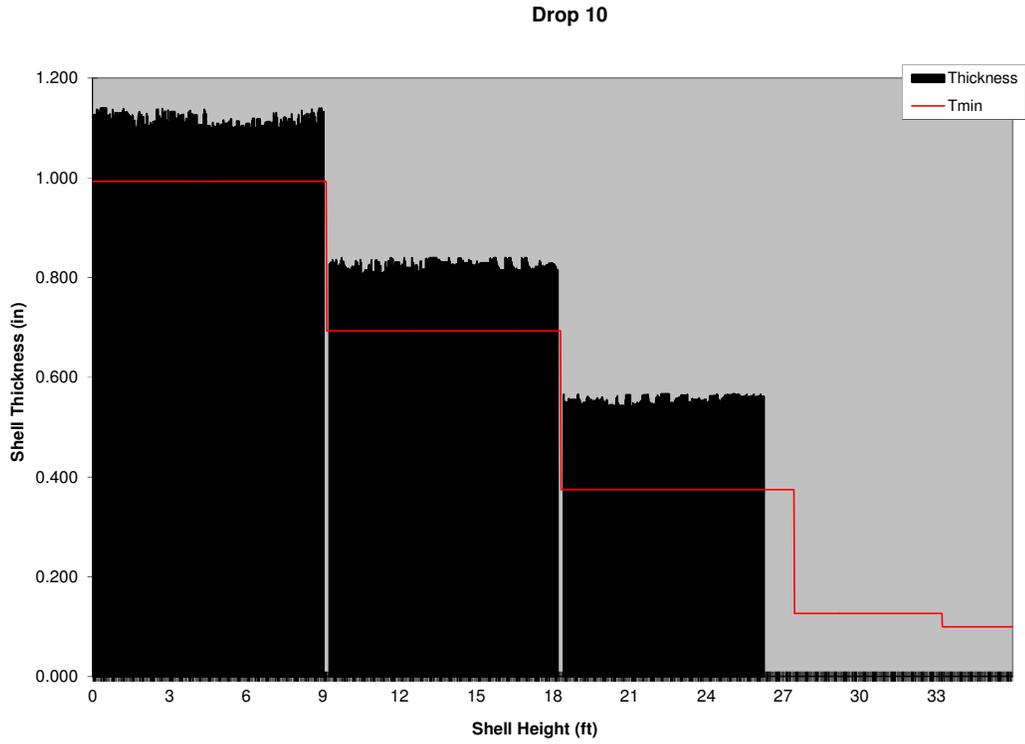
**DROP 10**

Drop 10	Min	Avg	Max
Course 1	1.100	1.116	1.140
Course 2	0.807	0.826	0.840
Course 3	0.537	0.556	0.567
Course 4	--	--	--

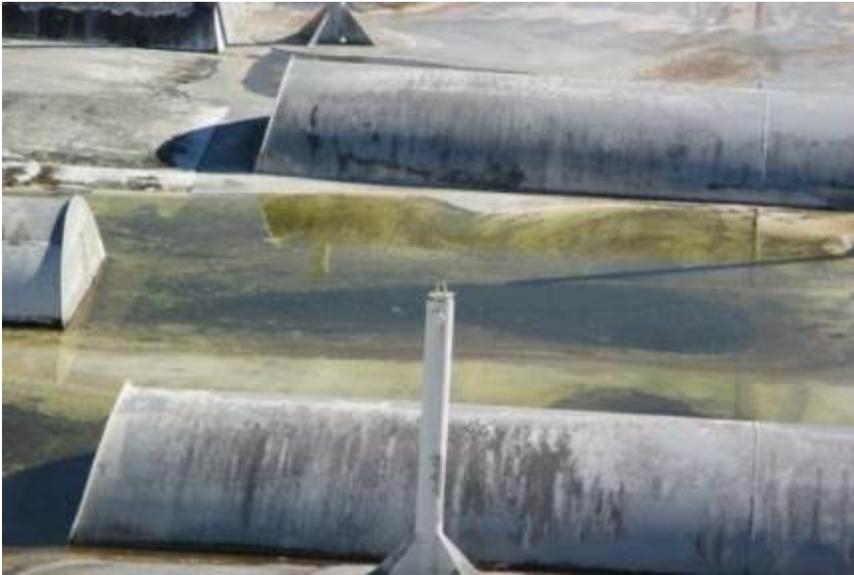
Standing Water on Roof Deck
