U.S. DEPARTMENT OF ENERGY
Strategic Petroleum Reserve
Project Management Office
New Orleans, Louisiana

**SHELL PIPELINE COMPANY LP
FY 2018 ANNUAL LEASE
PERFORMANCE EVALUATION OF THE
ST. JAMES (SUGARLAND) TERMINAL
(DE-RL96-97PO70010)**

October 24 & 25, 2018

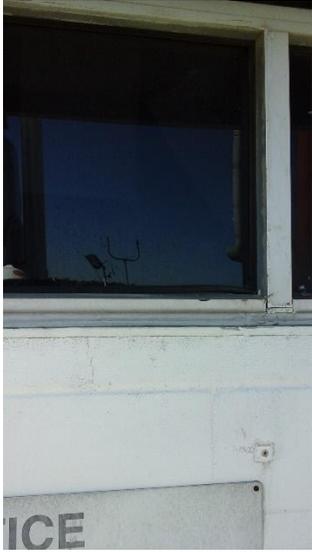
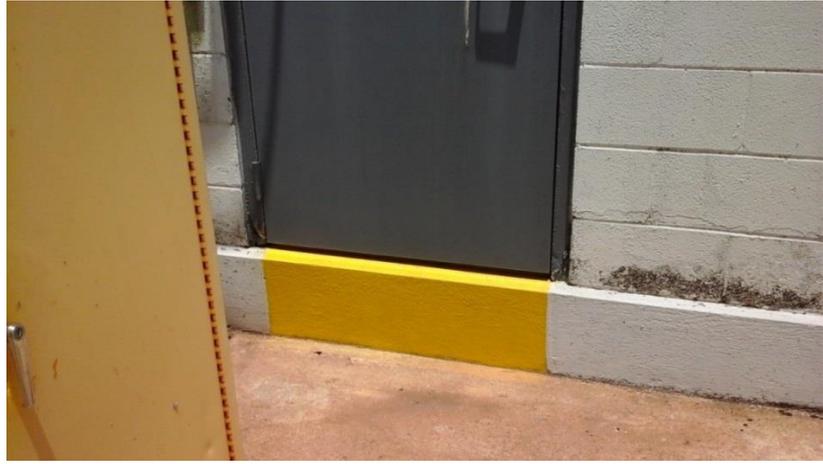
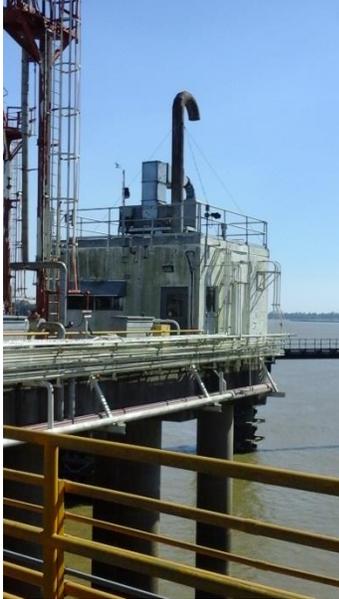
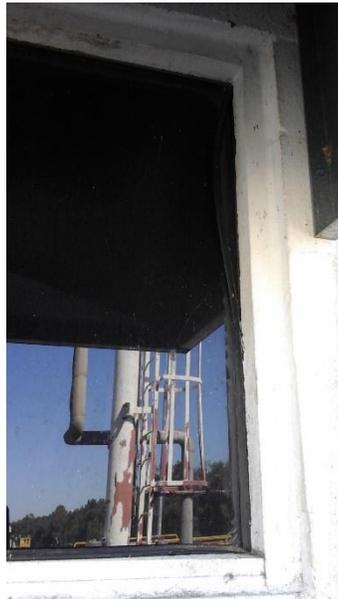
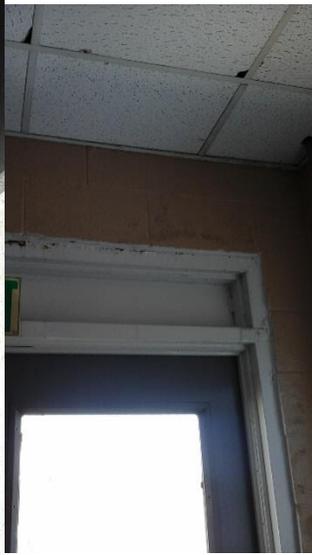
8. Building 714 (Foam Deluge)

- i. Oxidized paint on exterior walls and gutters**

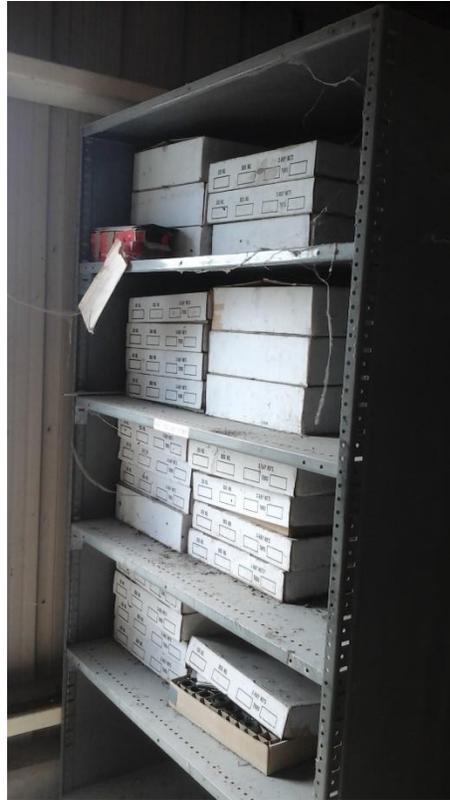
- **Equillion (circa 2002) pipeline records stored in flammable materials building (Non environmentally controlled) # 708.**

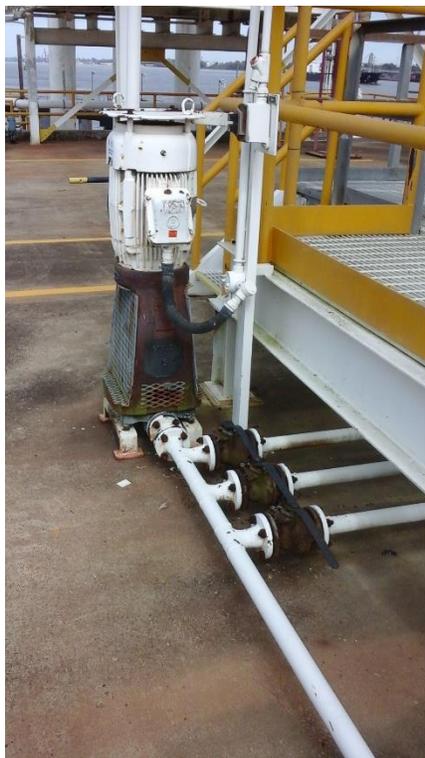
- Dock #2 loading arm purge pump base and arm drain valves need paint coating.
